# SCOPE OF WORKS

# ALUMINIUM WINDOW FRAMES

# TIMBER WINDOW FRAMES

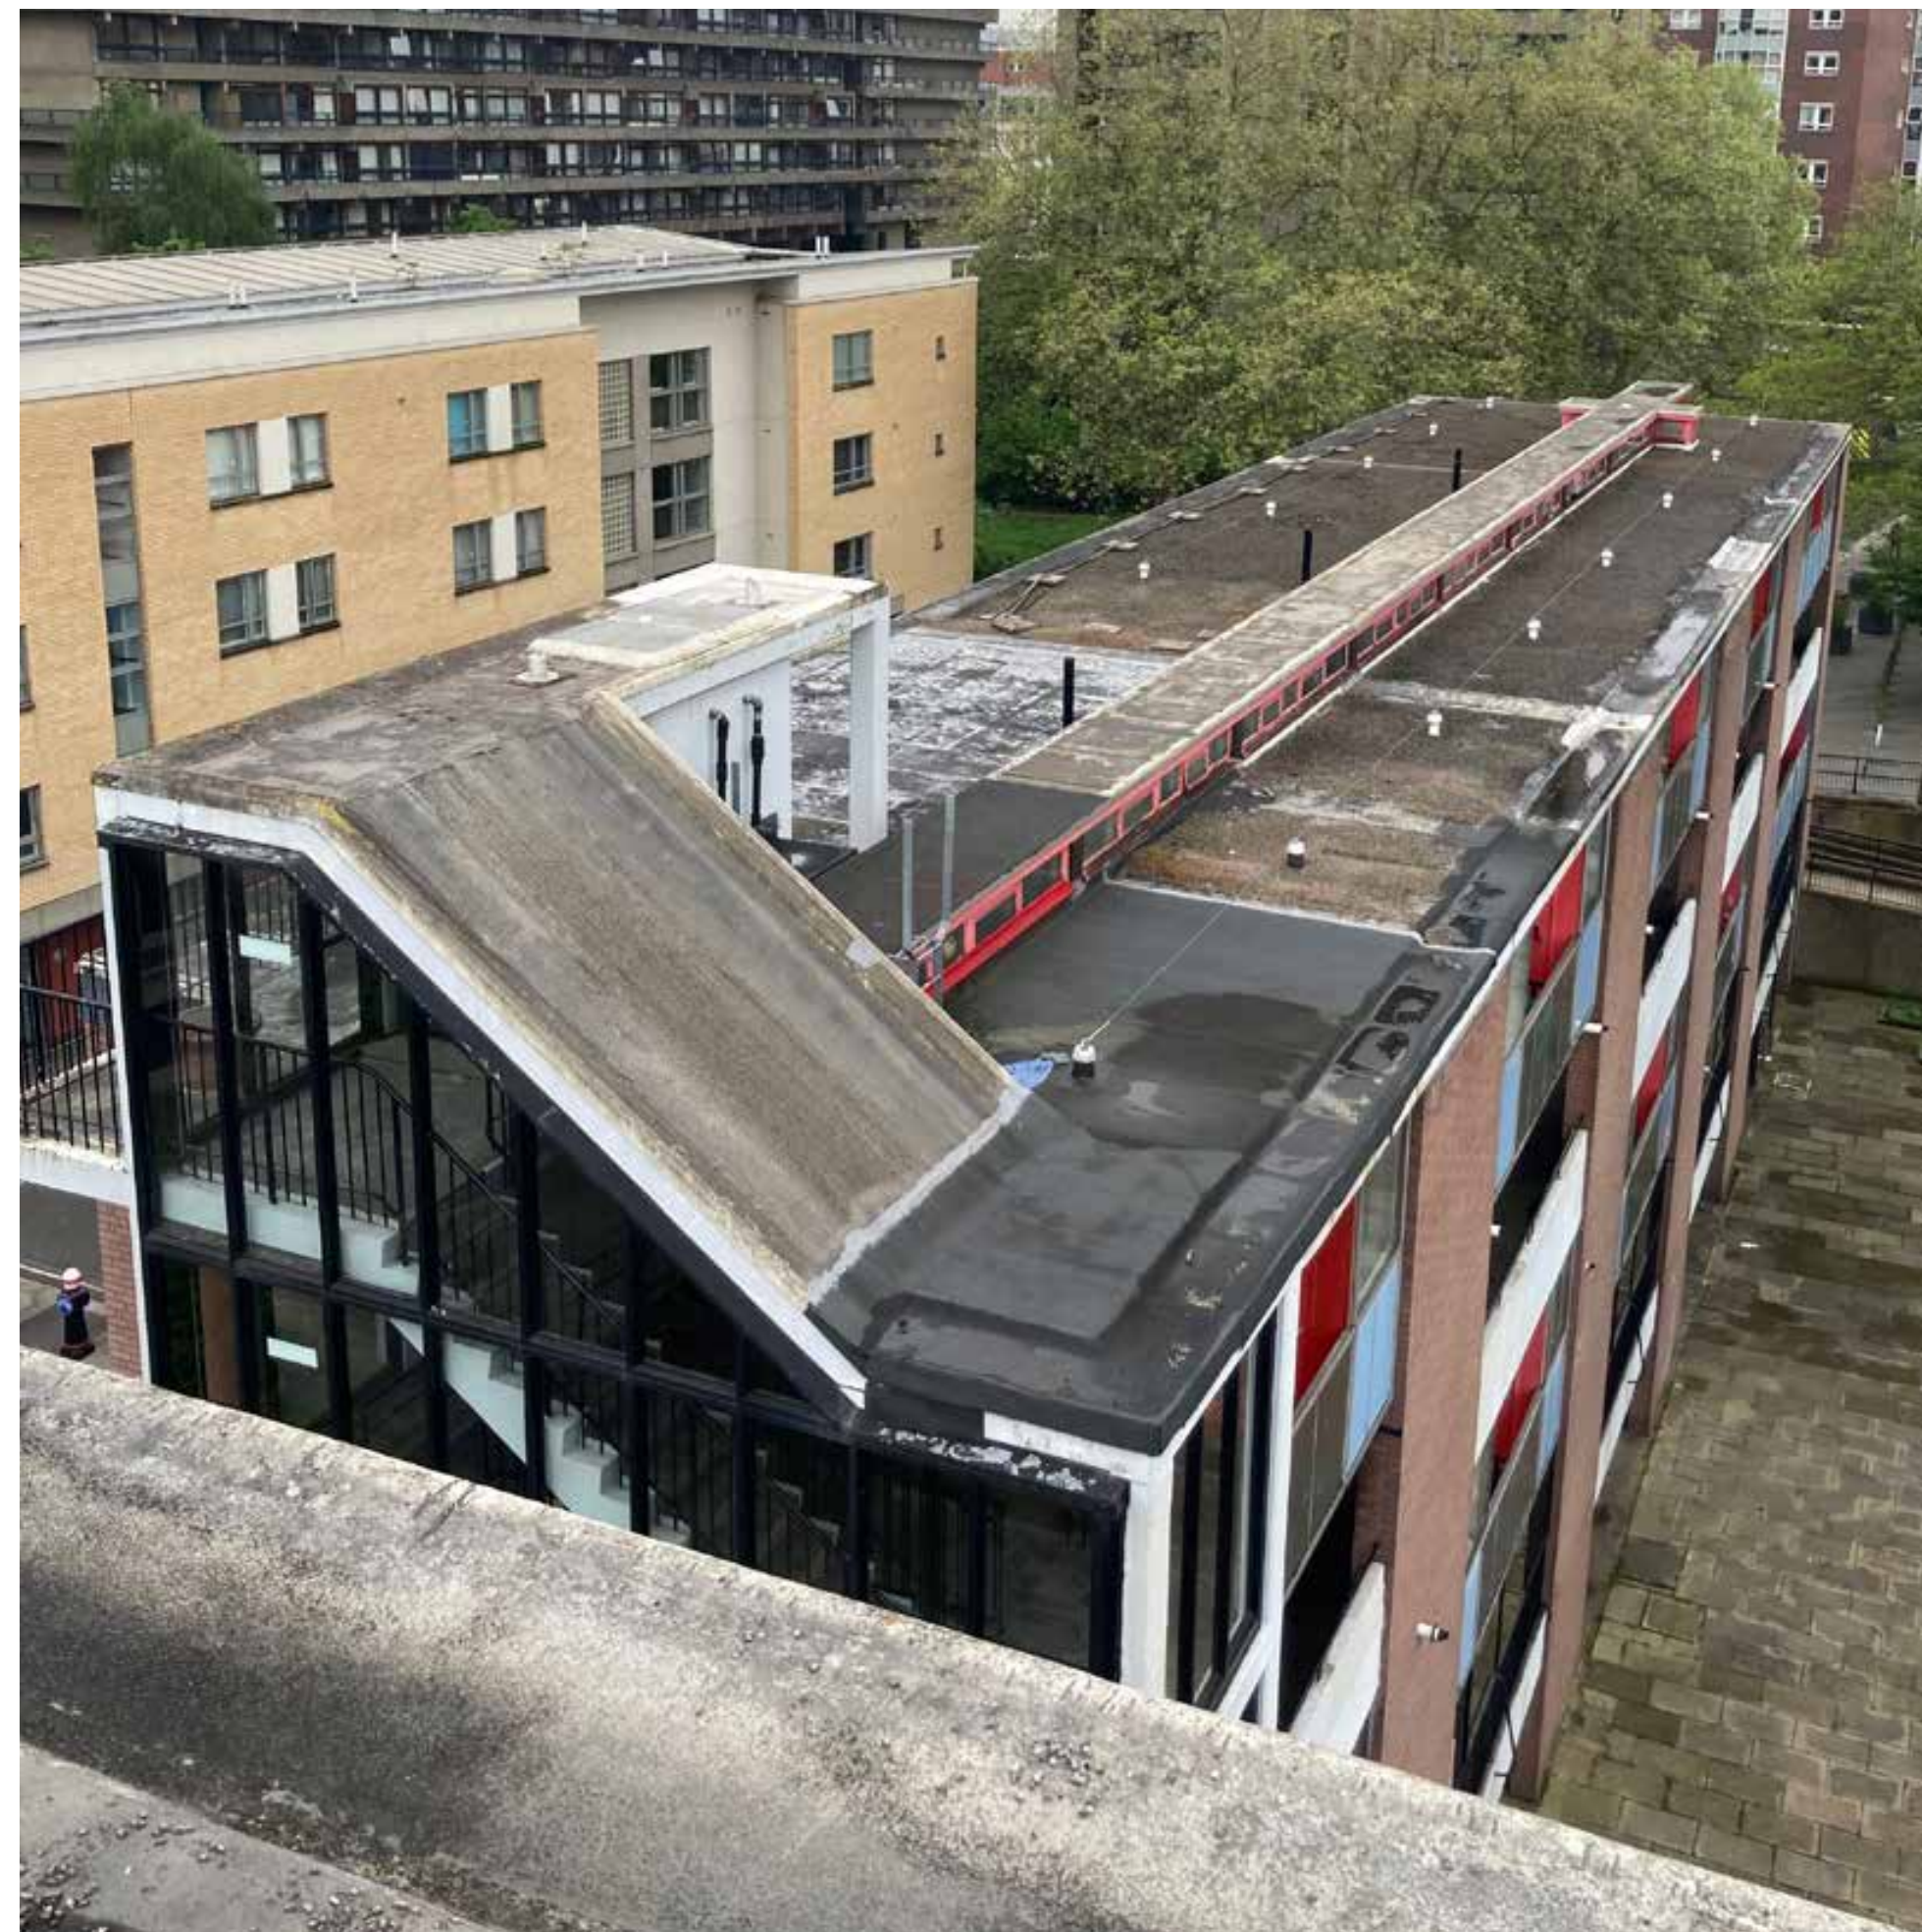
The softwood-framed windows which run the full length of the roof lantern are in poor condition. There are several factors likely to have contributed to the poor condition of these frames:

Above: View of the roof lantern lights of Cuthbert Harrowing House from the roof of Bowater House. The bold red colour of the window frames is thought to be original and the key historically significant feature of these window frames.

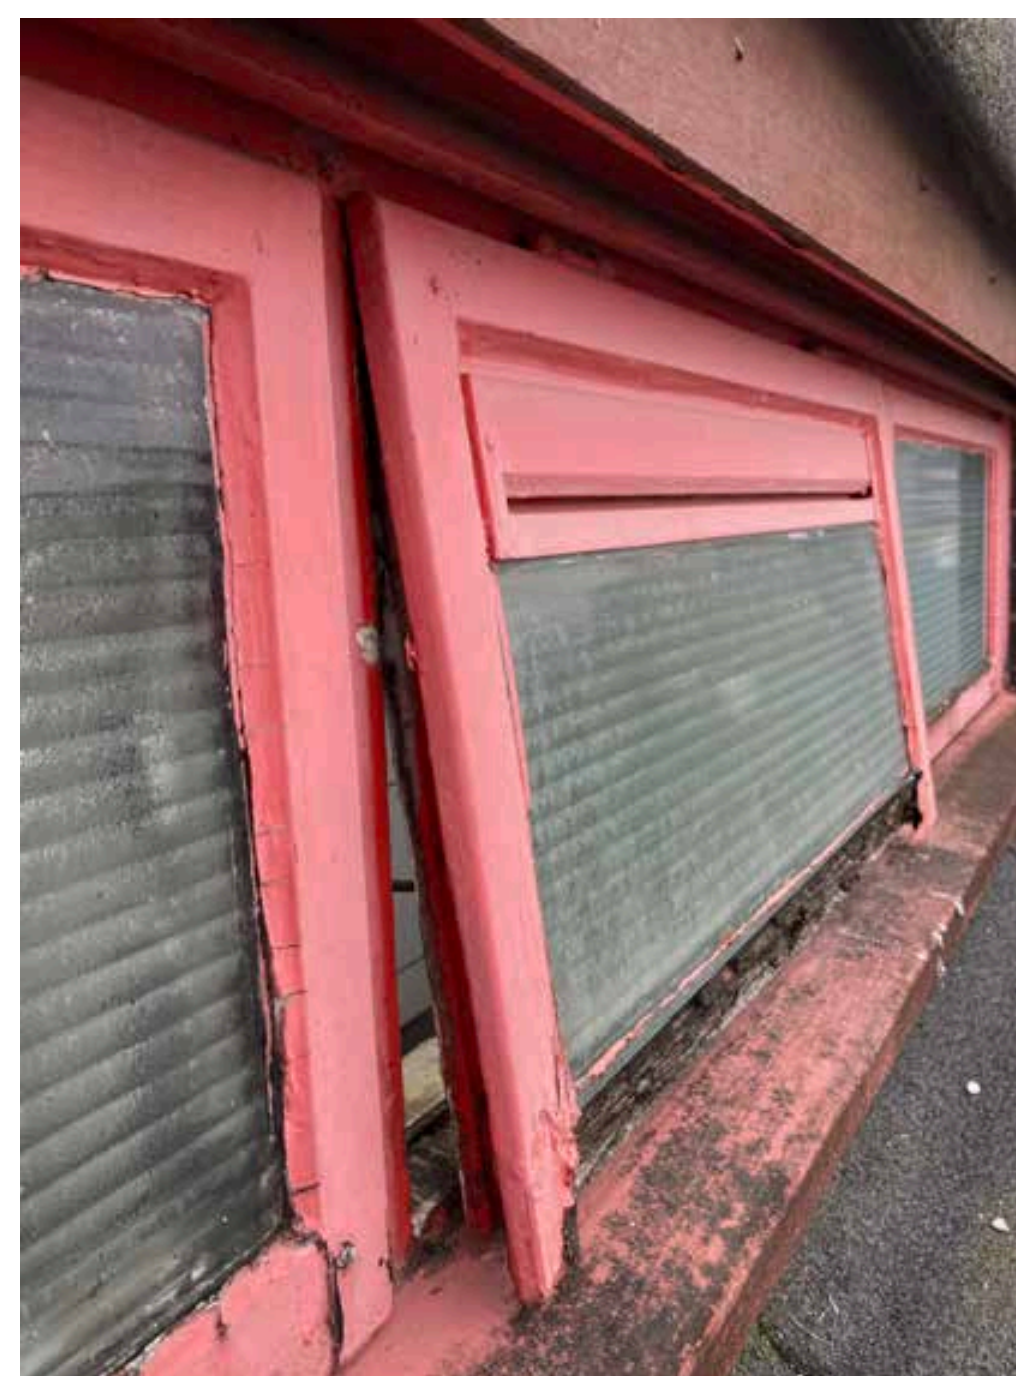
Left: The roof lantern windows are made from softwood and are in generally poor condition. In this photo the entire bottom piece of frame of the opening light is missing and would require an extensive splice, or complete replacement. Staining on the timber sill is thought to be from constant water dripping from the lantern light roof.

Taking all of this into account, we propose replacing these windows with a solution that requires less frequent access, decoration and repair. This would improve longevity without diminishing their historic significance.

New thermally broken aluminium windows and cills are proposed.

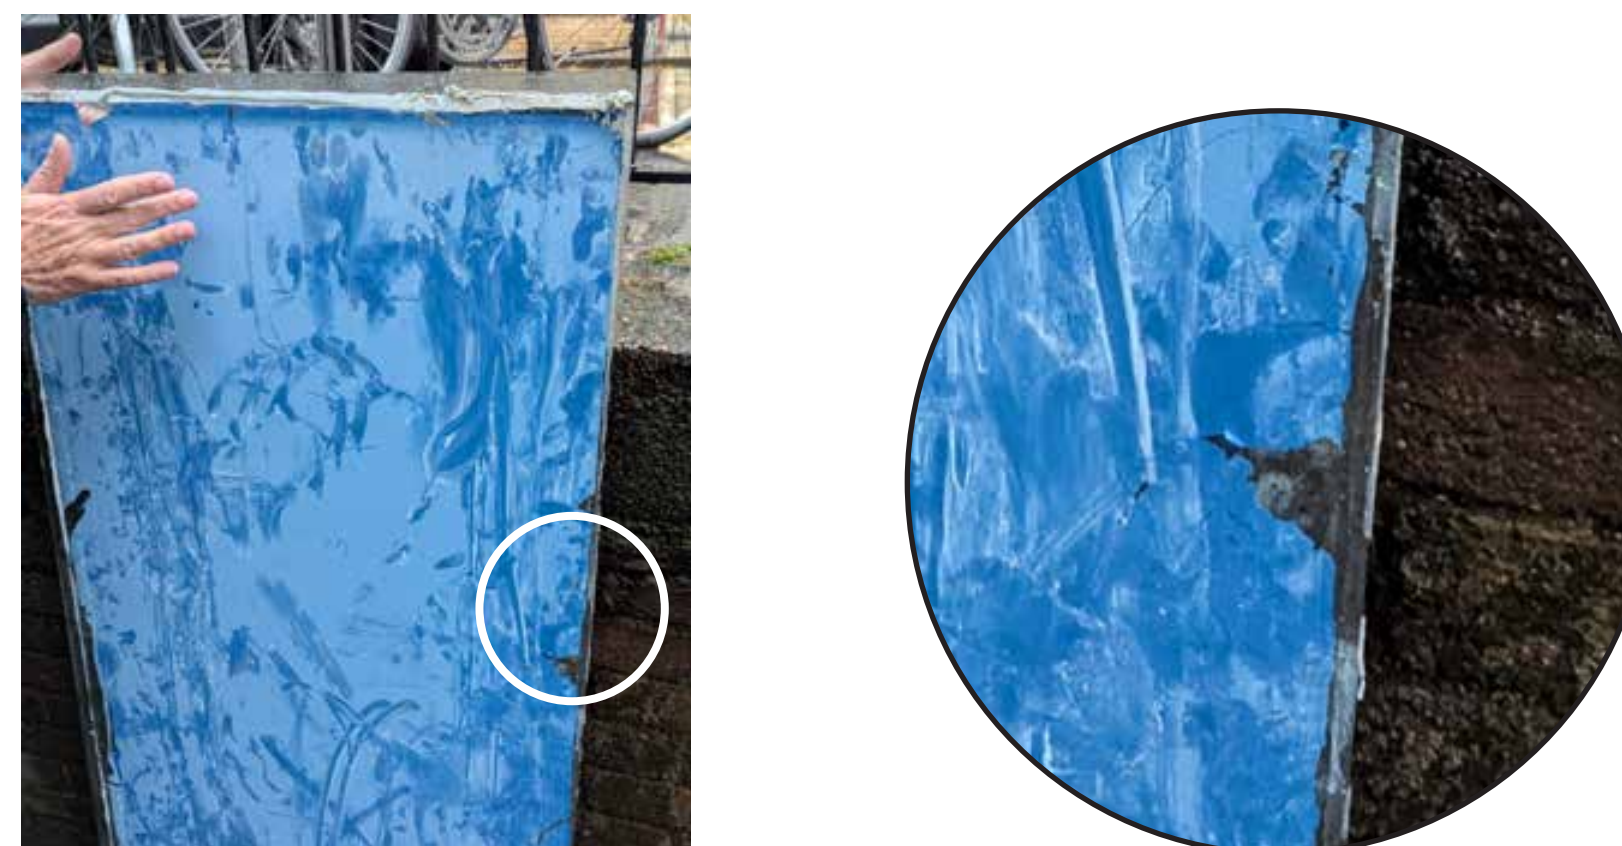
The blue paint is now faded and has a chalky residue on its surface, both of which have changed the appearance of the glass.

Sheet of coloured glass removed from Cuthbert Harrowing House. The colour to the glass is created with a surface applied paint. This has faded and has developed a chalky residue. The outer face of the glass is smooth and the inner face textured.

Our working assumption is that the blue paint used on the glass at CHH would have matched the deep blue used elsewhere on the estate. Therefore, it is proposed to replace the glass in the spandrel panels with new textured glass with a blue ceramic coating to the rear. A trial sample of this glass has been installed at 2 Bayer House.

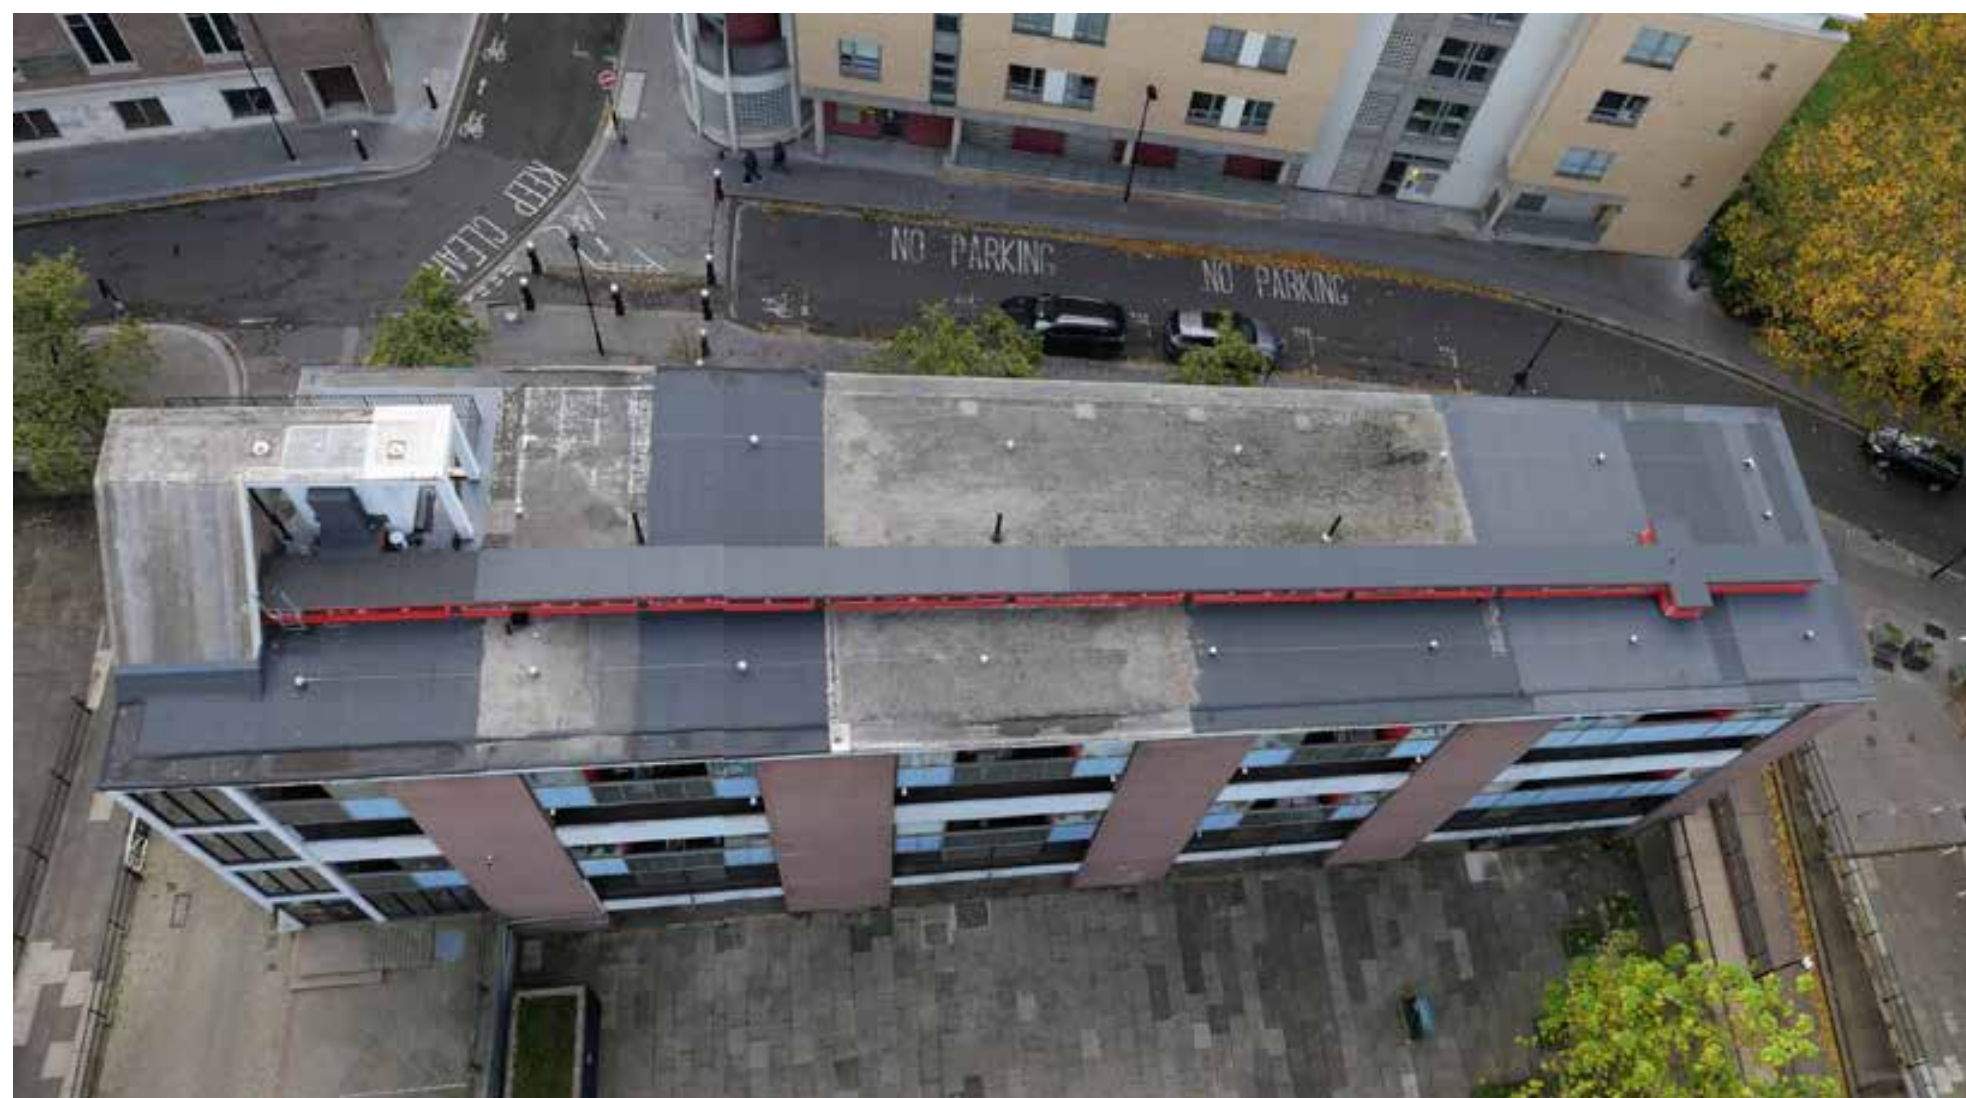
The roof coverings at Cuthbert Harrowing House are beyond the end of their serviceable life, with leaks having been an issue in a number of locations. Patch repairs have been carried out on a piecemeal basis, with some success in resolving leaks. It is now proposed to completely replace all roof coverings.

*The roof of Cuthbert Harrowing House as seen from Great Arthur House. Numerous patch repairs can be seen. The proposal extends to all roofs including the main roof, the roof of the lantern light and the roof of the staircase.*

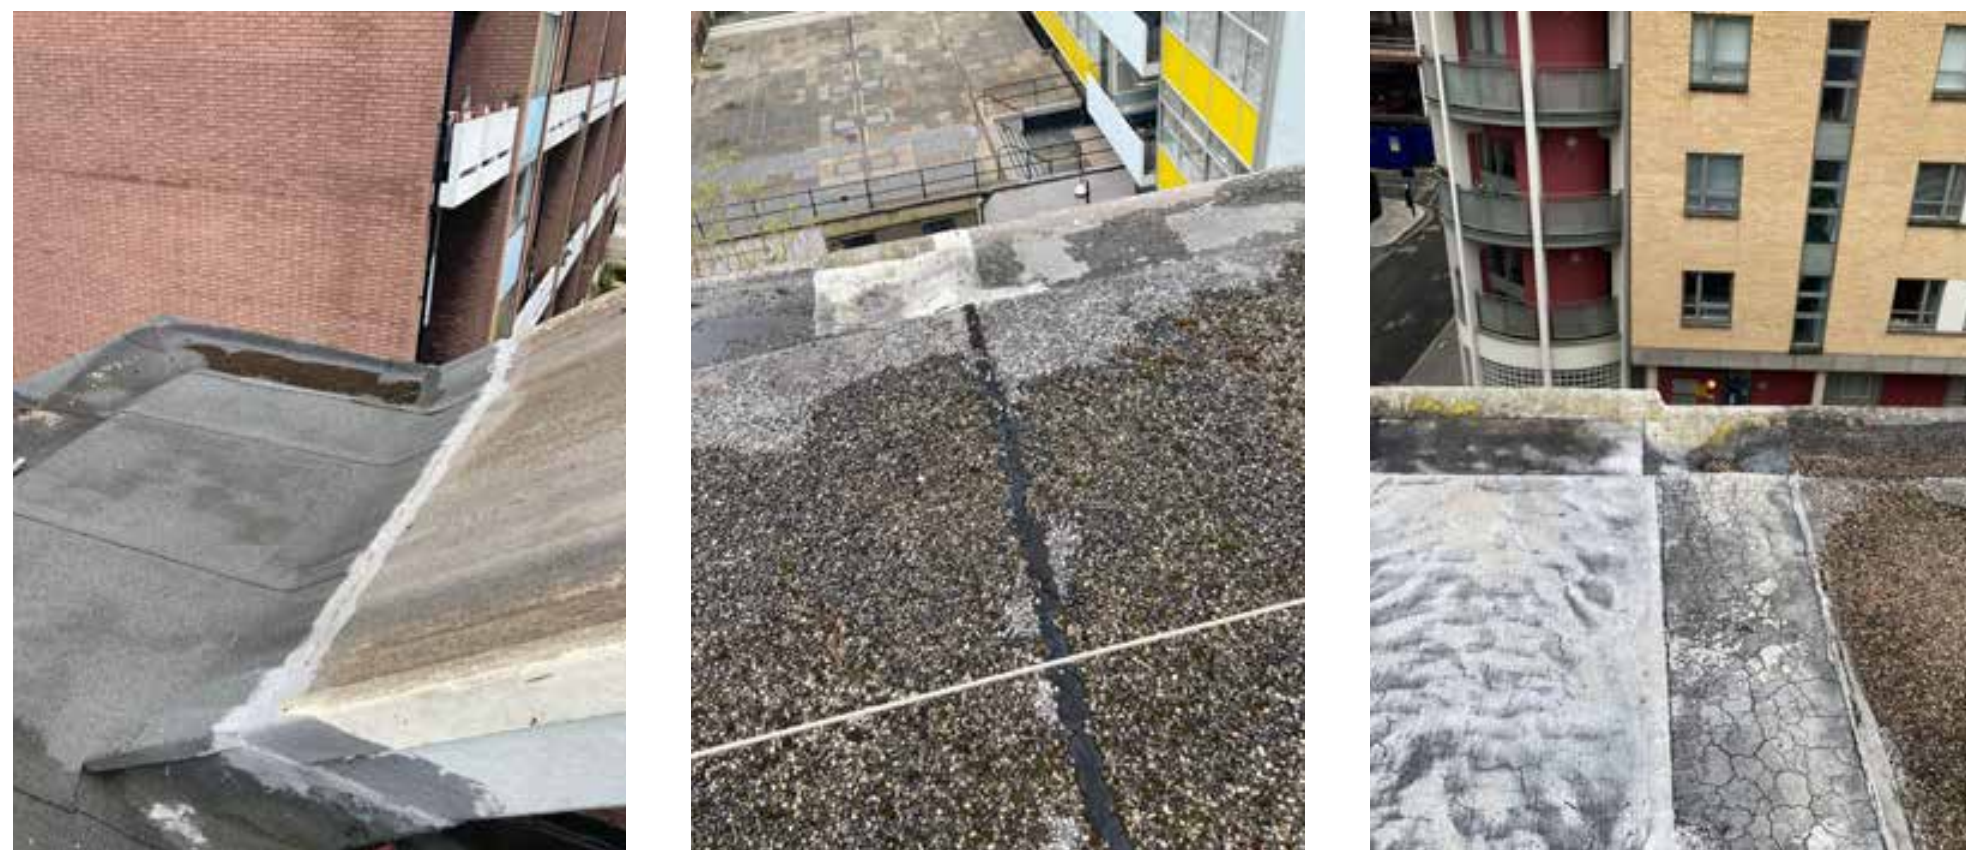
Overall, the condition of the roof coverings is poor. The photographs below show poor execution of previous repairs, deteriorating roof coverings and fascias, standing water, vegetation and detritus.

*Detailed photos showing conditions of the Cuthbert Harrowing House roof showing pooling water, patch repairs, joints in finishes and aging coverings.*

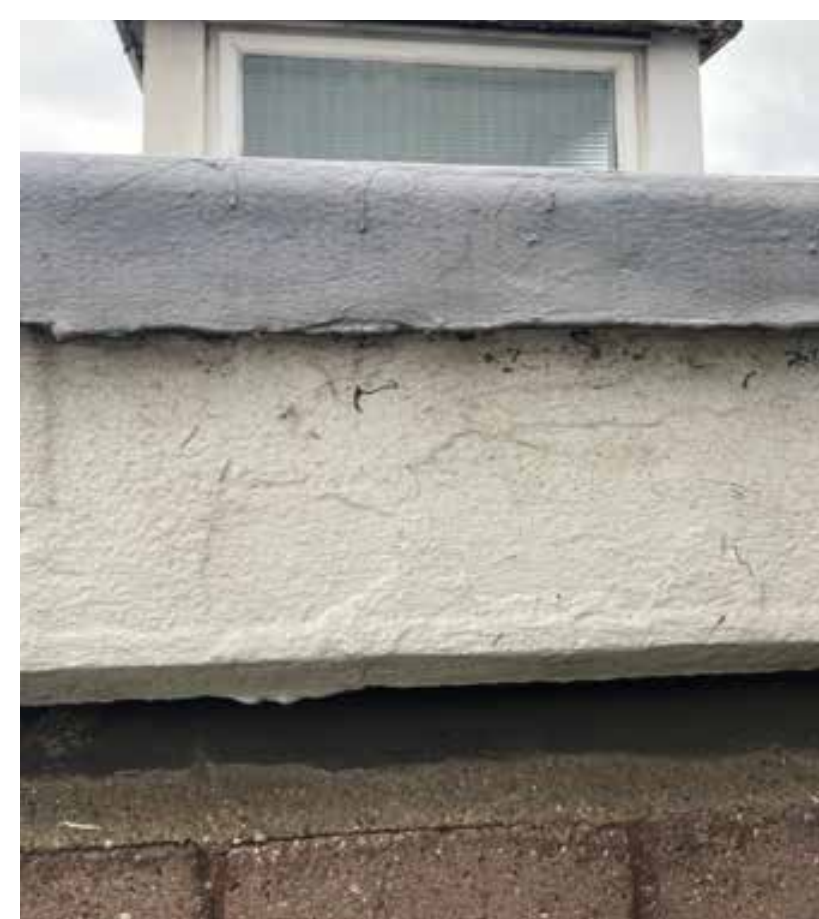
Asphalt waterproofing visible on front of roof slab

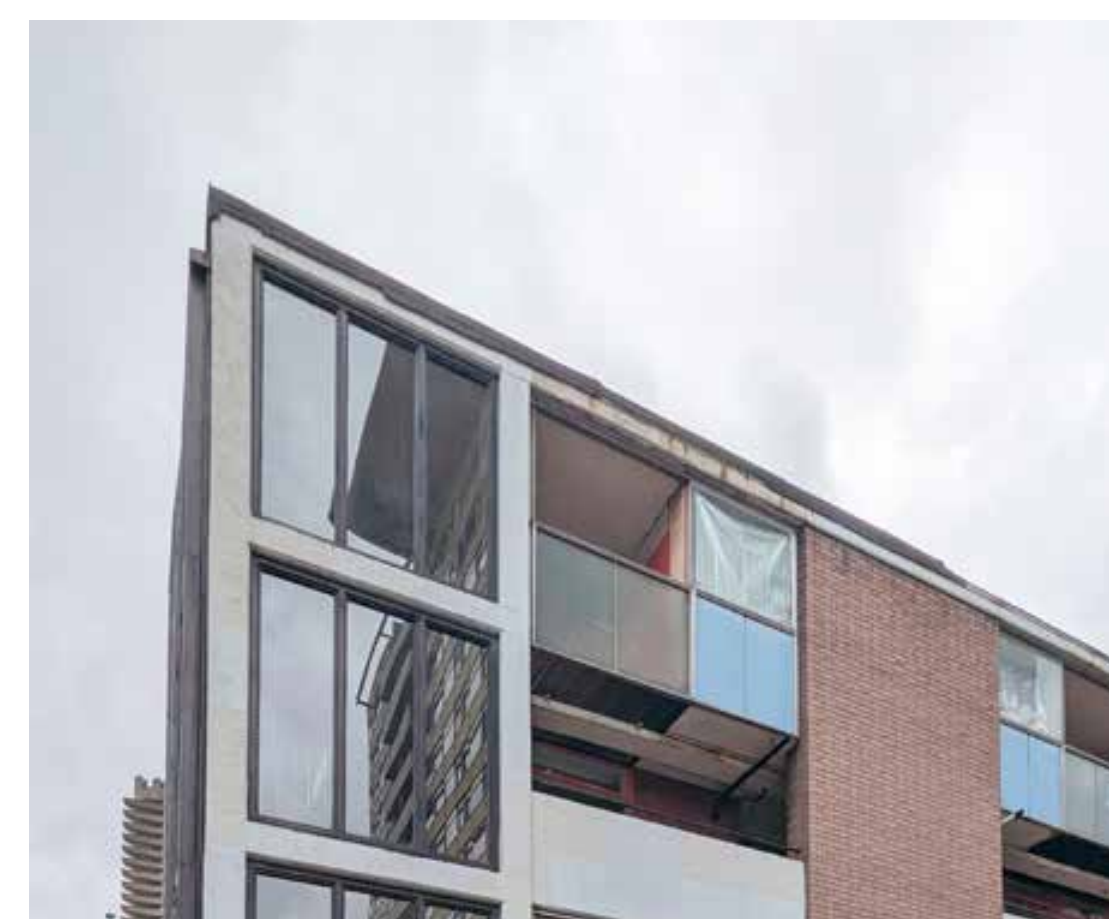
The crisp edge of the roof has been lost over time following addition of new coverings.

A new polyester powder-coated aluminium trim (white) will be installed at the roof edge, concealing the falls of the gutter and creating a clean, consistent edge to the roof.

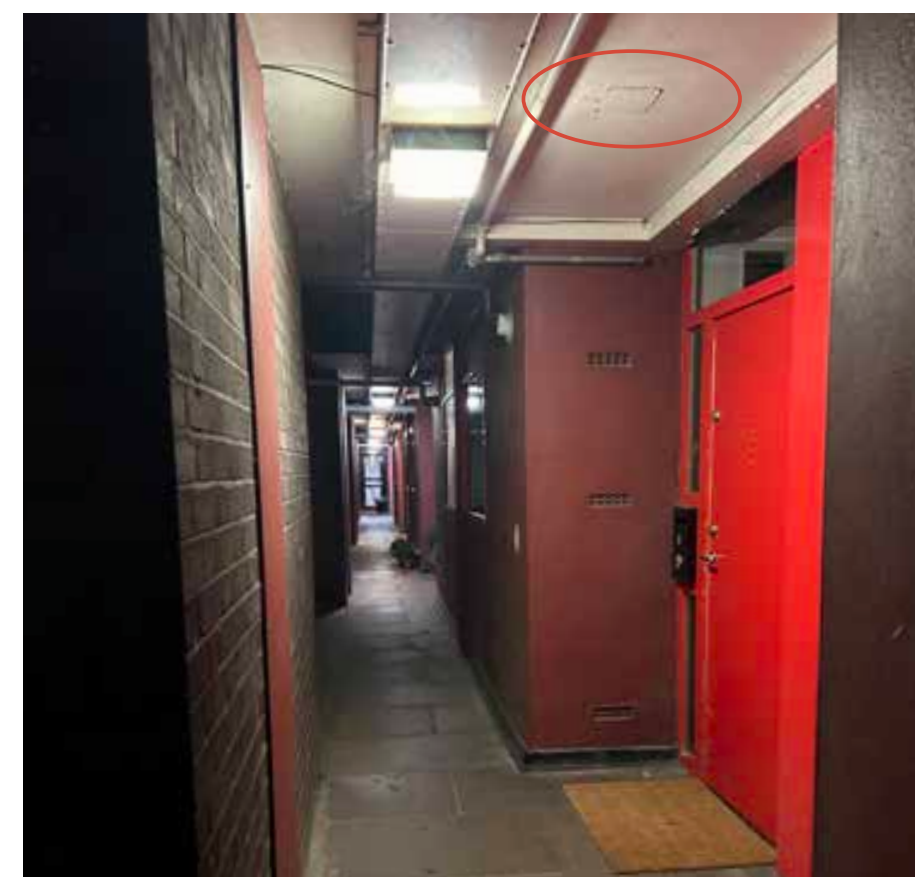
*Recess for original maisonette light fitting covered by metal plate*
