# SCOPE OF WORKS

Great Arthur House previously had separated project briefs: repairs to kitchen and bathroom windows, fire compartmentation upgrades, and sprinkler installation. The revised brief consolidates these elements and has been relaunched as one complete package of works.

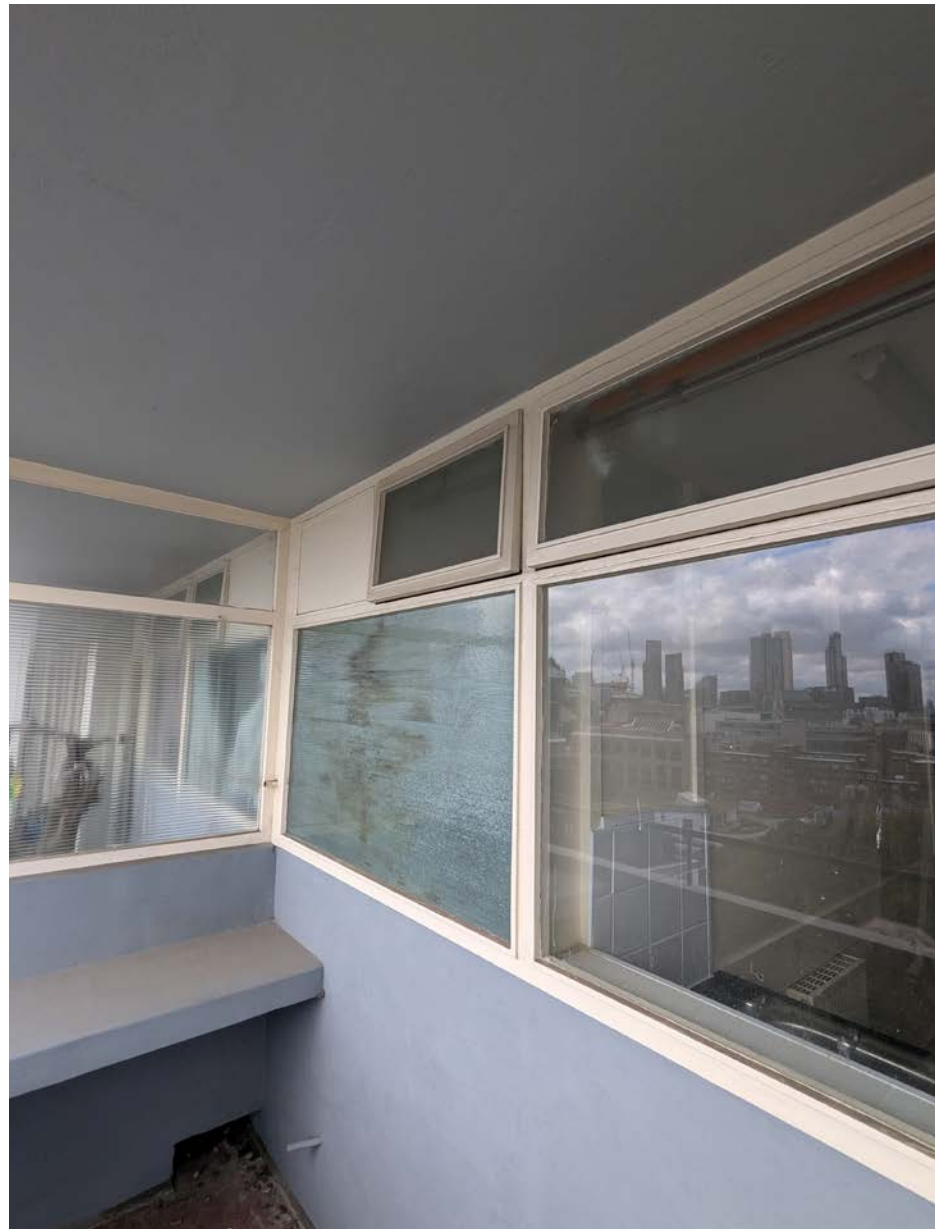
Timber-framed kitchen and bathroom windows. The top-hung opening windows sit proud of the frame when closed.

The bathroom and kitchen windows are timber-framed with single glazing. The windows and opening casements are made from softwood, which expands and contracts as its moisture content changes with the weather. As a result, the windows can become difficult to open or close, and at other times gaps may form, allowing draughts to enter.

New hardwood opening casements are proposed to replace the existing top-hung windows. Hardwood is generally more durable and dimensionally stable than softwood, making it less prone to movement caused by changes in moisture. This should help the windows open and close more reliably over time. The hardwood will still be painted to match the rest of the frames.

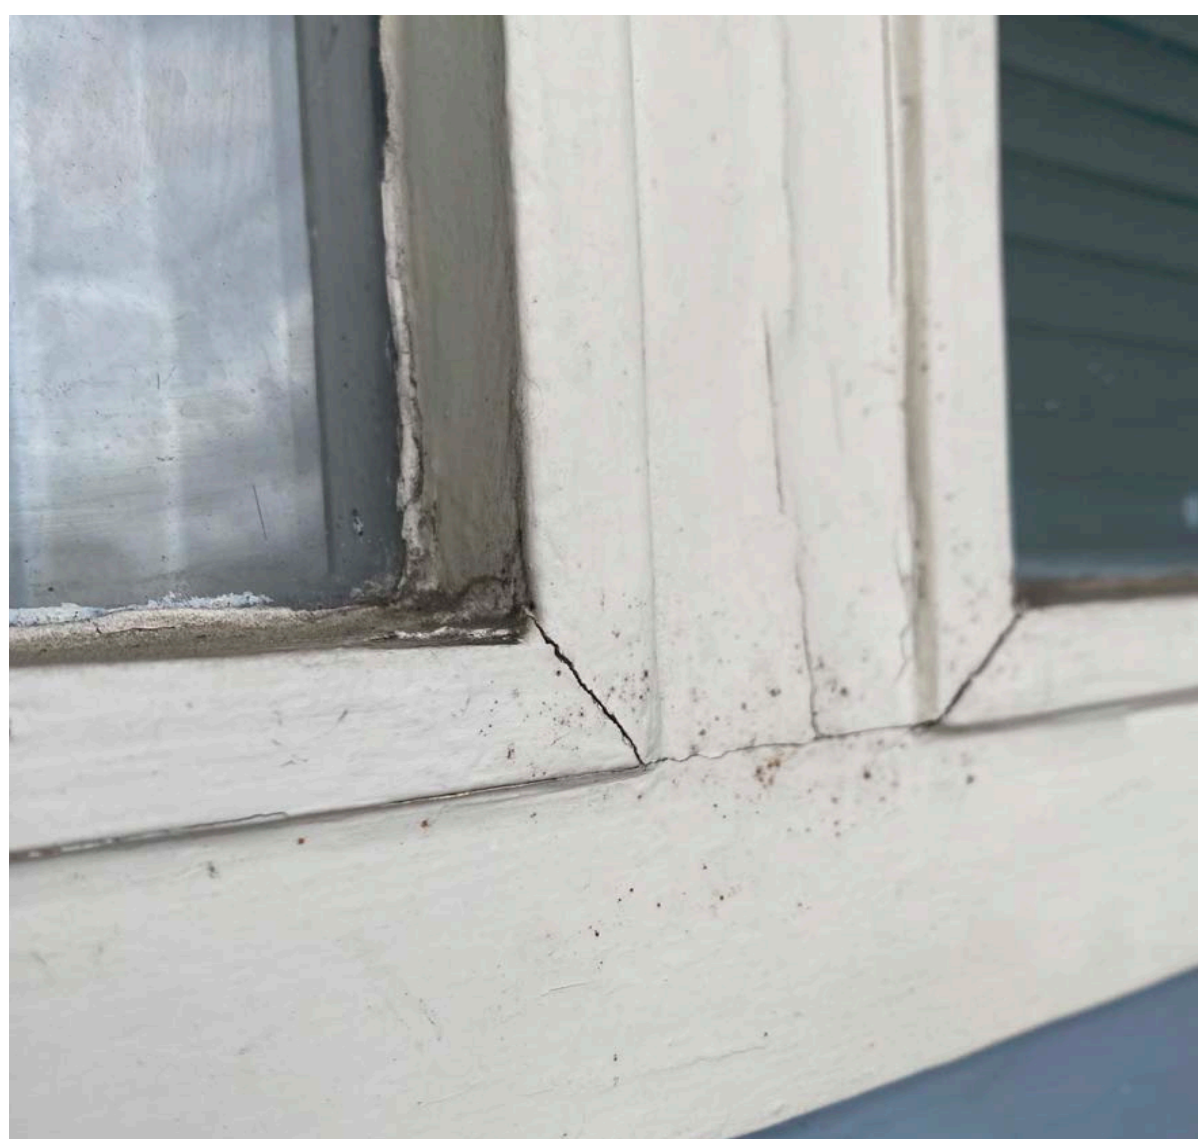
Timber beading projects out from the frame.

The timber glazing beads are also made from softwood and project beyond the face of the surrounding timber frame. The amount they project varies between flats.

The existing timber beading across all windows, opening and fixed, will also be replaced with hardwood.

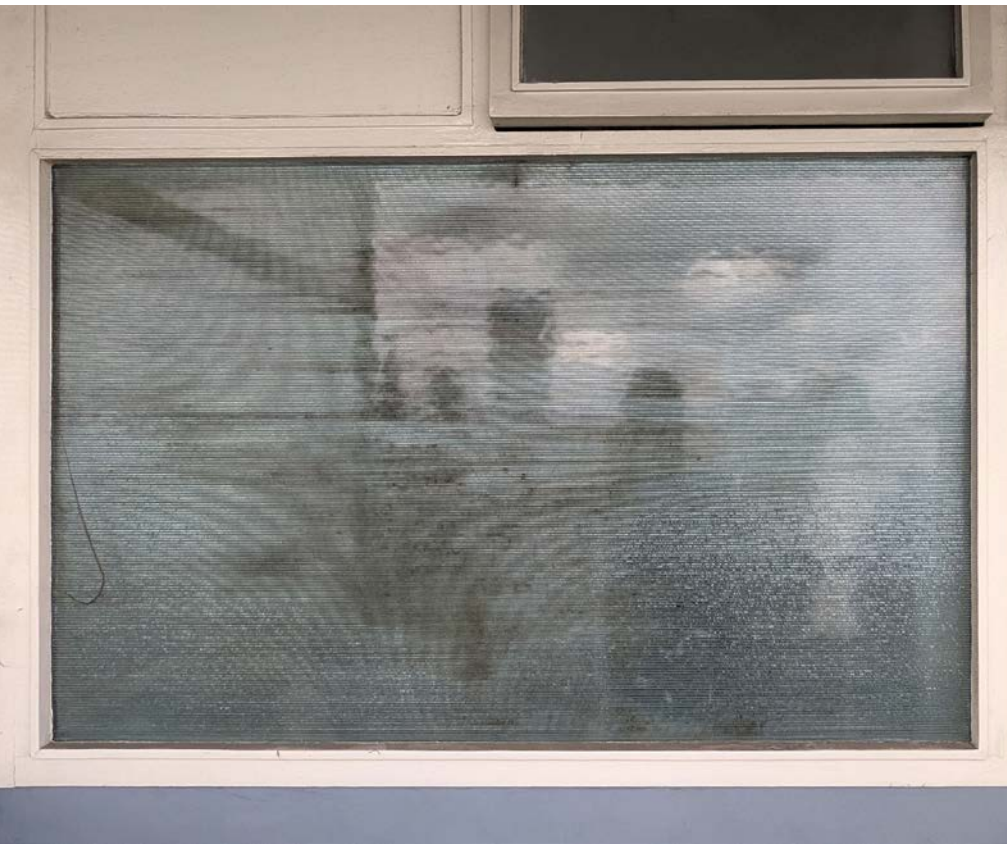
Existing reeded glass installed only in bathroom low-level window.

Reeded glass is only used in the low level window of the bathrooms. This will be replaced with a composite glazed unit consisting of an outer layer of reeded glass with an inner layer of vacuum glass.

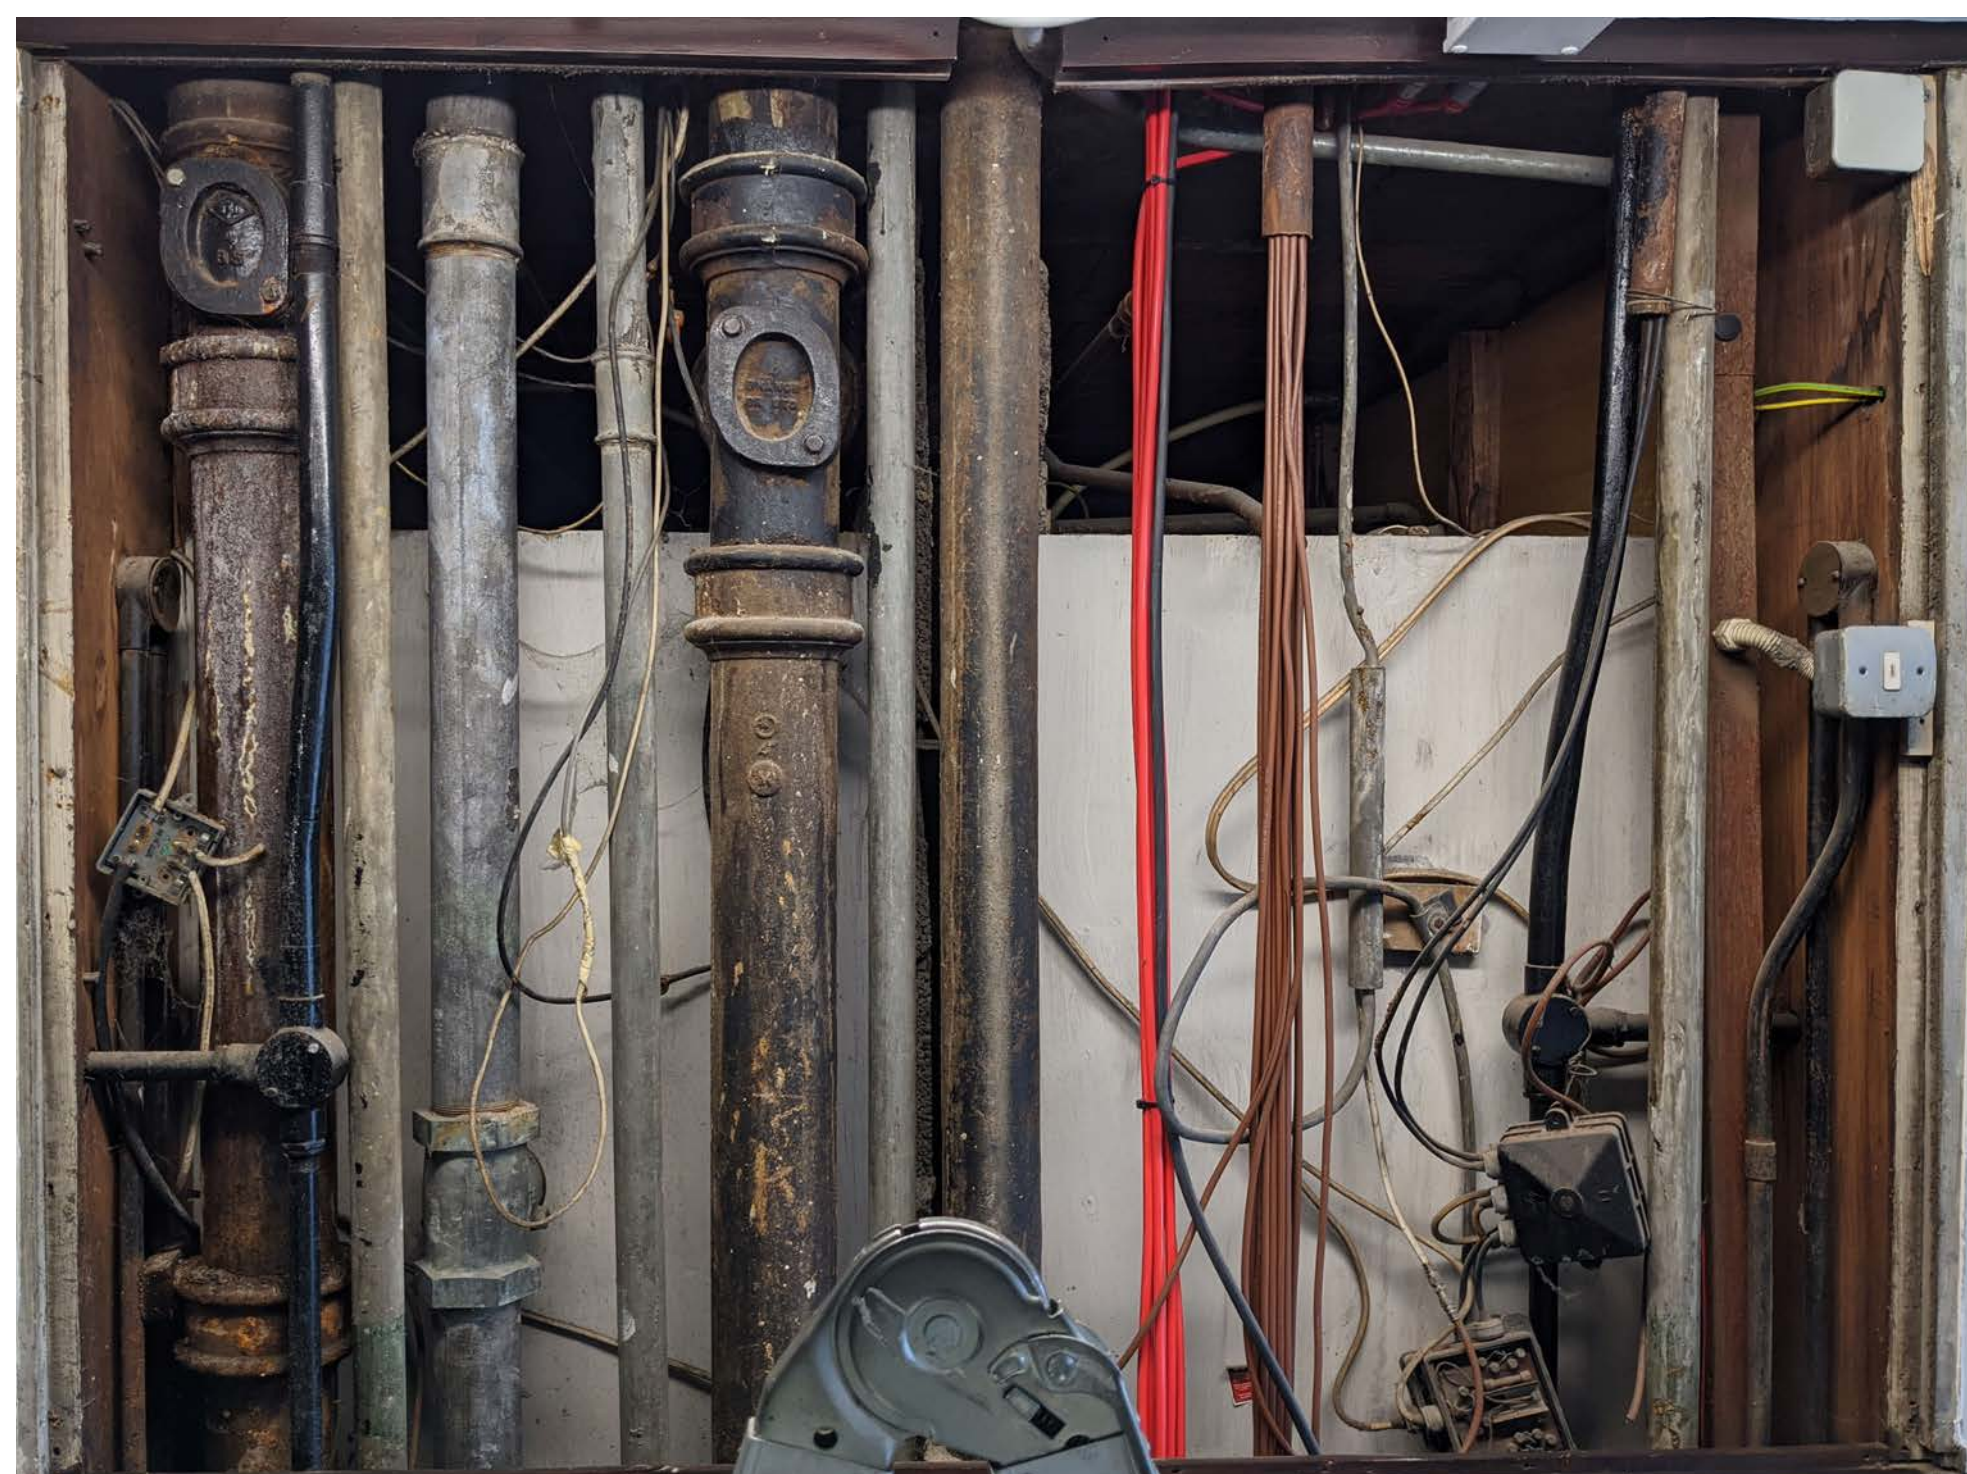
*Risers contain: gas, water, electricity, telecommunications, rainwater and foul drainage services.*

The risers are heavily congested, with some redundant services still in place, leaving insufficient space for the additional services required as part of the proposed works.

As the existing risers are heavily congested and additional services are required, new risers are likely to be needed elsewhere in the building.

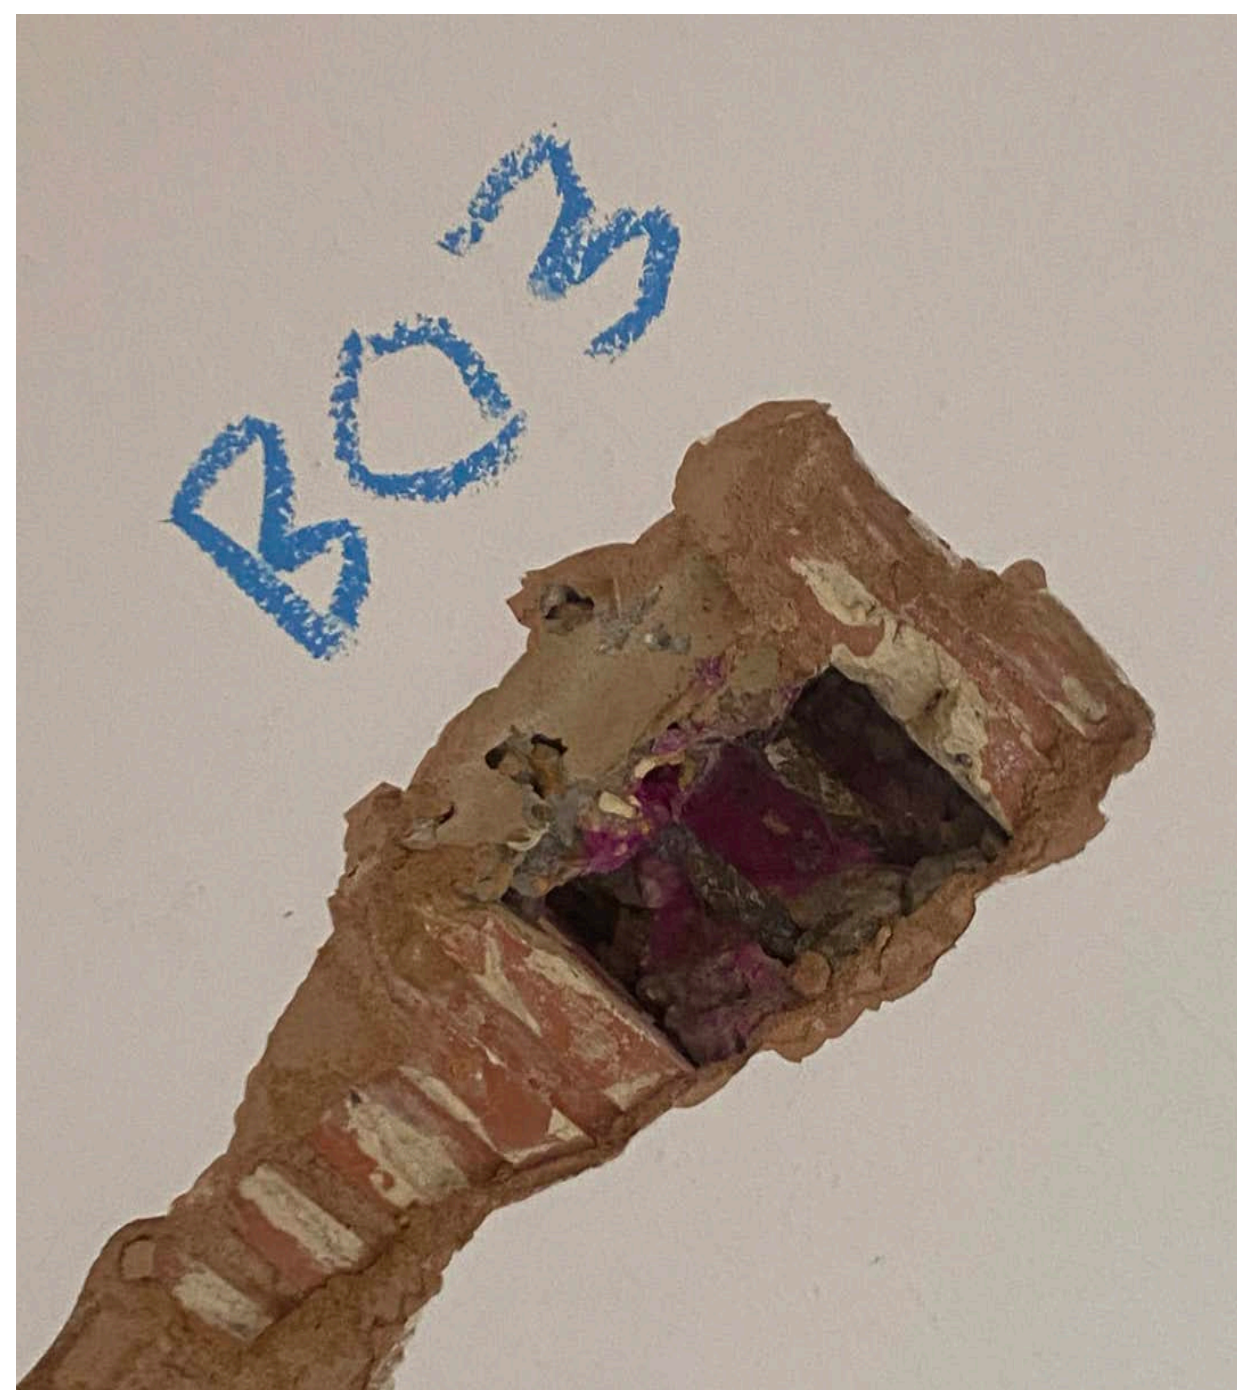
An intrusive survey found the concrete cover to the steel reinforcement varied from approximately 7 mm to 23 mm, with some areas below the 20 mm typically required for fire protection and durability. The survey also identified carbonation in some poorly compacted concrete, meaning the concrete around the steel was no longer providing adequate protection against corrosion where moisture and oxygen are present.

Steel in the reinforced concrete ribs with poorly compacted concrete carbonation.

The team have explored potential remedial solutions to enhance the fire protection to the underside of the slabs, with the aim of achieving 120 minutes fire resistance.

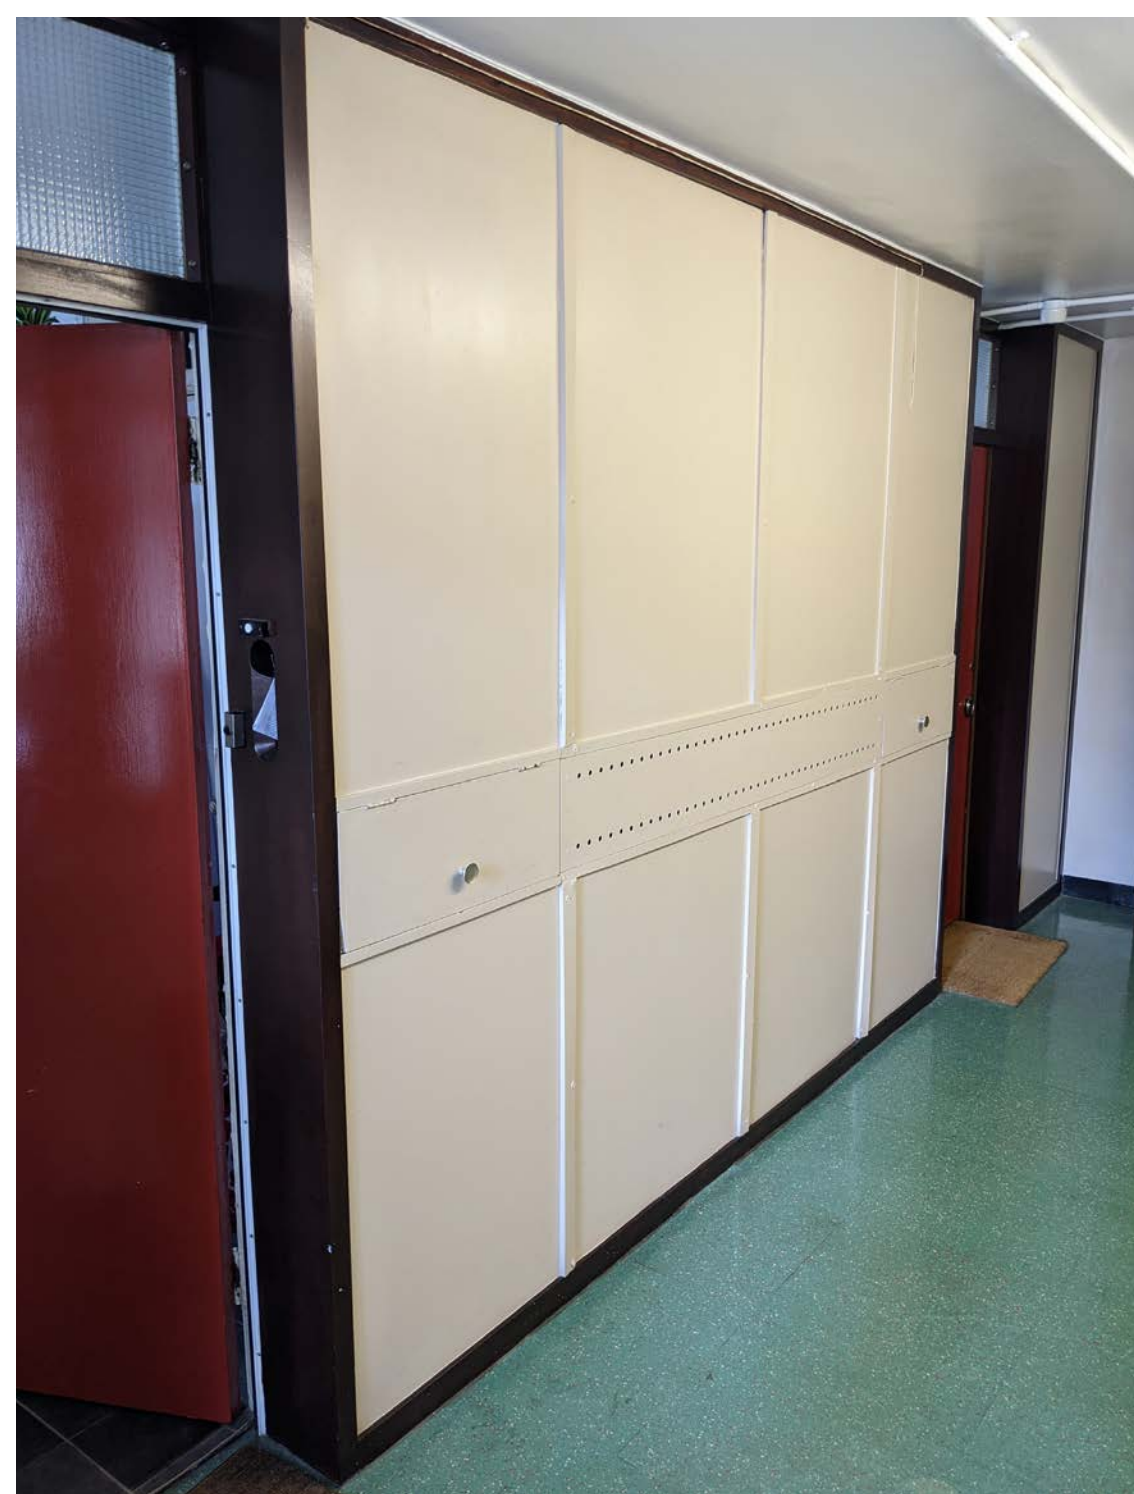
The screens are constructed from timber with original infill panels that provide limited fire resistance and are understood to contain asbestos, requiring careful management during any works.

Screen with heritage features and integrated flat entrance door.

Installing the lining to the rear of the screen creates a simple, continuous fire-protecting line while allowing the front of the entrance screens to retain their historic appearance. However, the letterboxes and parcel hatches would no longer be accessible from inside the flat. Furthermore, the two storage cupboards inside the flat could no longer be used and another would be slightly reduced in size.

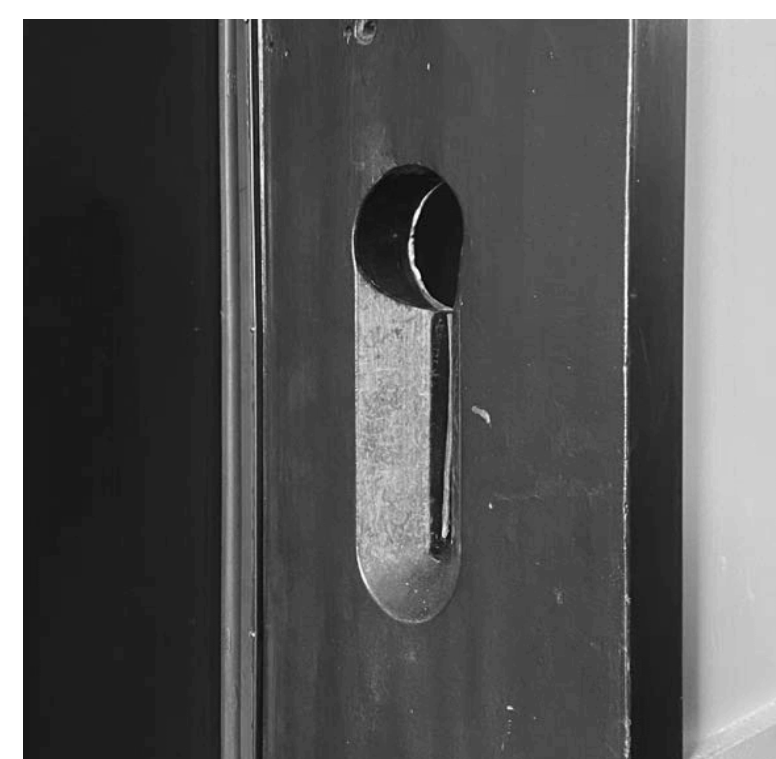
They also contain original features namely the parcel hatches and letterboxes. These openings create potential routes for fire and smoke spread. As a result, the entrance screens provide only limited fire protection between the flats and the communal escape routes.

Letterbox.

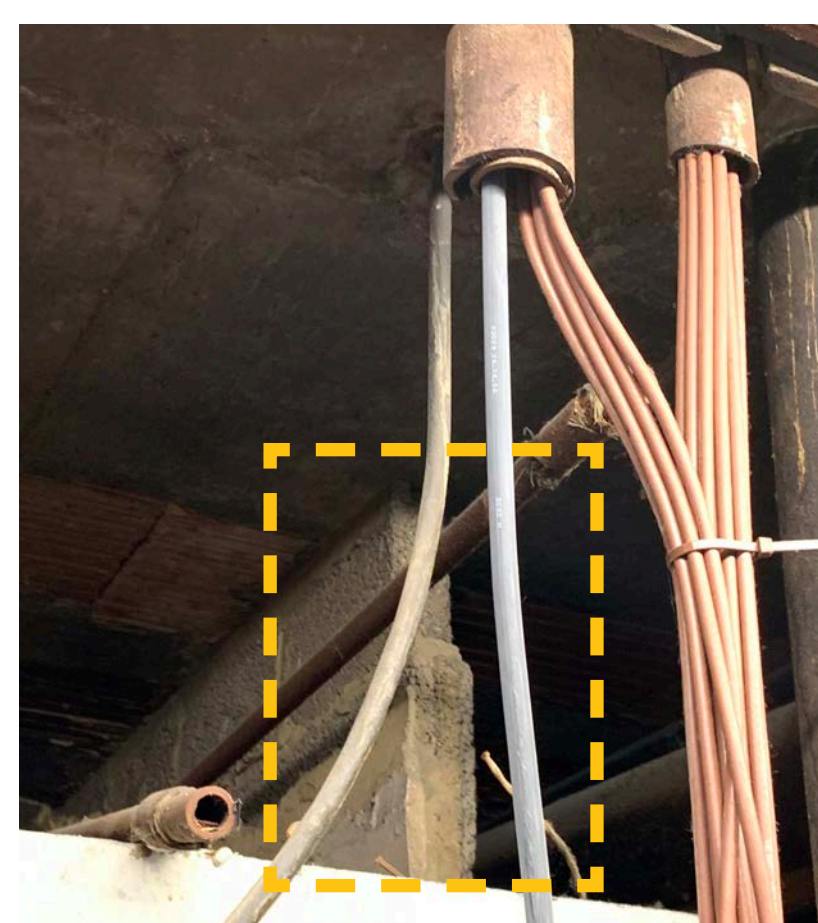
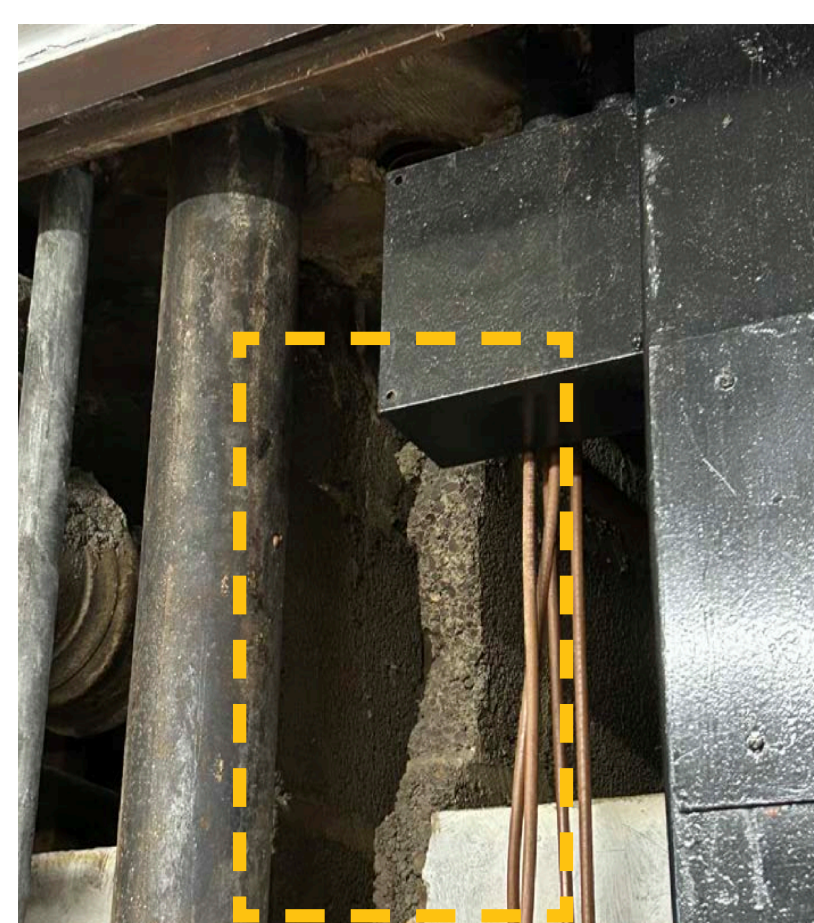
The vertical services riser is shared between a pair of neighbouring flats and also connects to the building's communal areas. The wall separating one flat from the neighbouring flat was open within the riser cupboard.

Because the separating wall between the flats does not fully continue through the riser space, it does not provide the level of fire separation that would normally be expected between homes. As a result, smoke or fire could potentially pass through the riser area and spread between neighbouring flats.

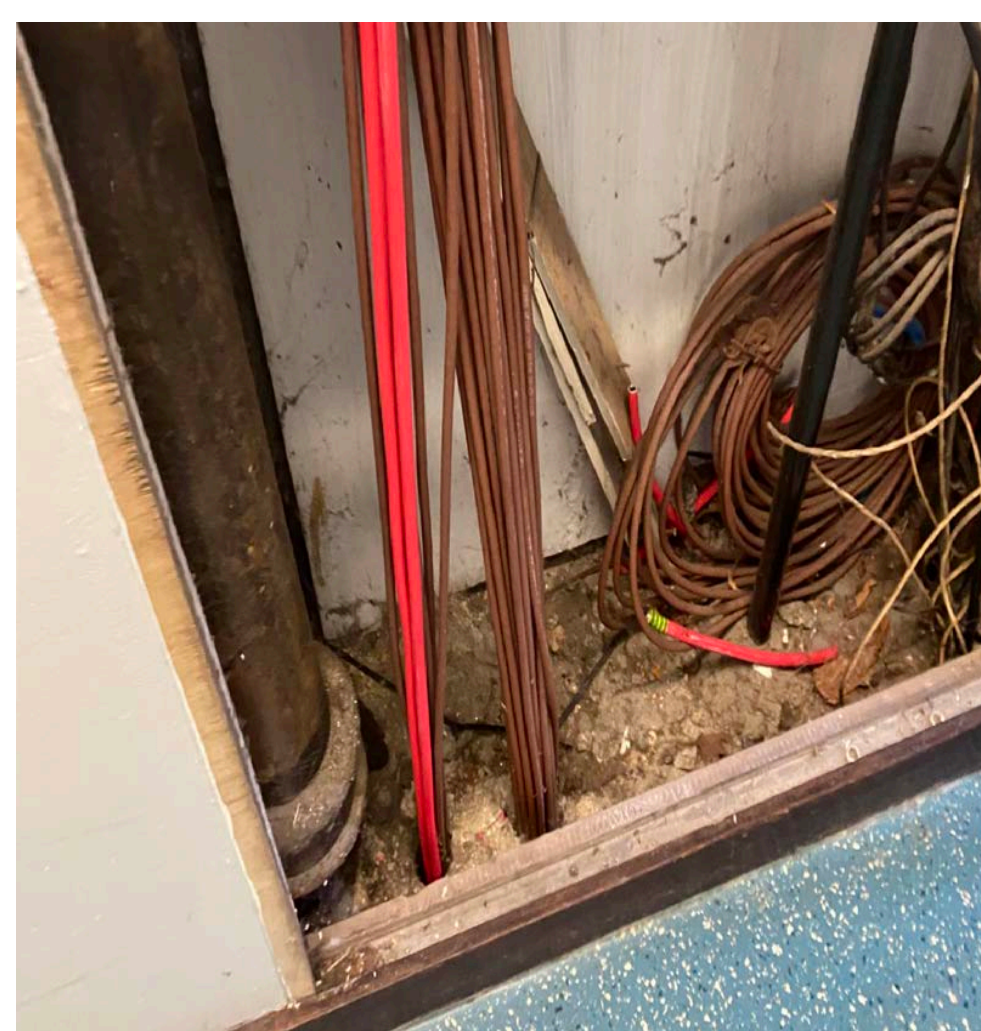
A survey of the service risers found that many openings around pipes and cables passing through the floors and ceiling had not been properly fire-stopped. These gaps could allow smoke and fire to spread between floors, flats and communal escape routes.

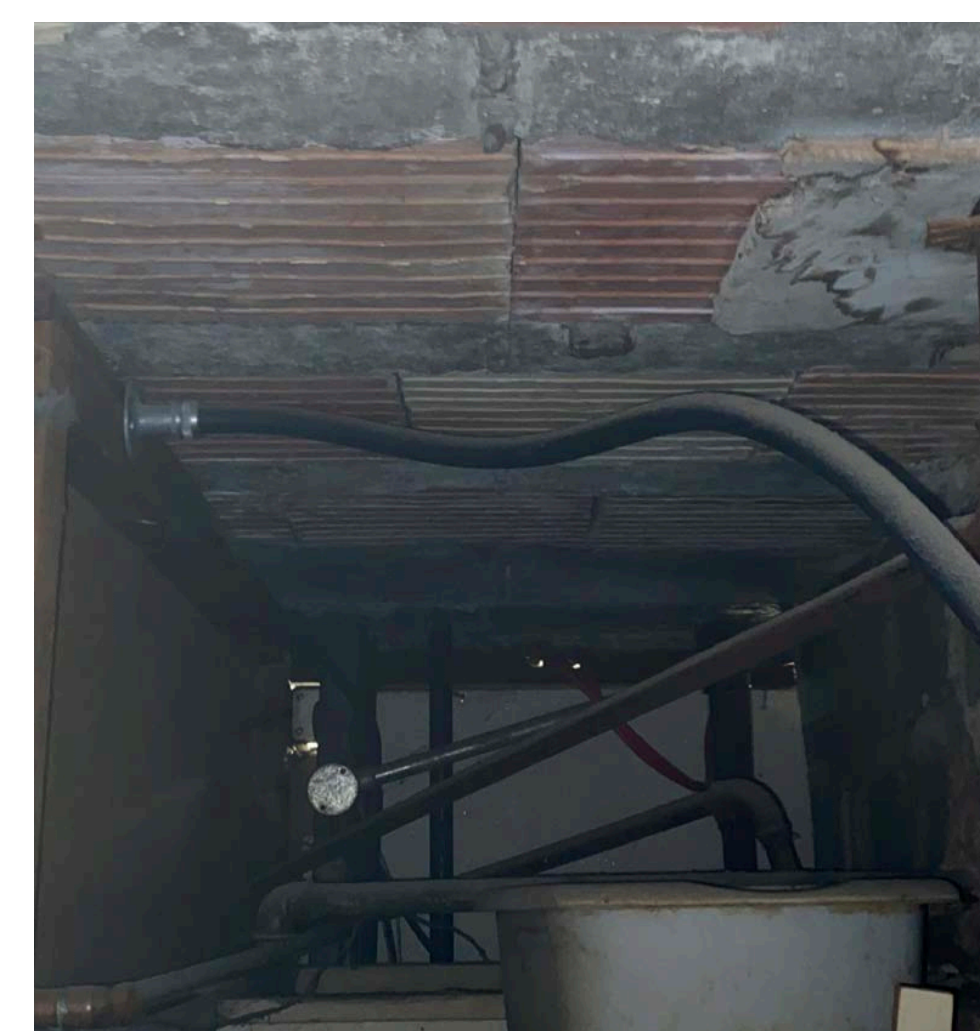
During the inspection, it was possible to see the back of the riser panels from inside this boxing. Communal lighting from outside the flat was clearly visible through this space, showing that the wall and enclosure do not properly separate the flats from the communal areas.

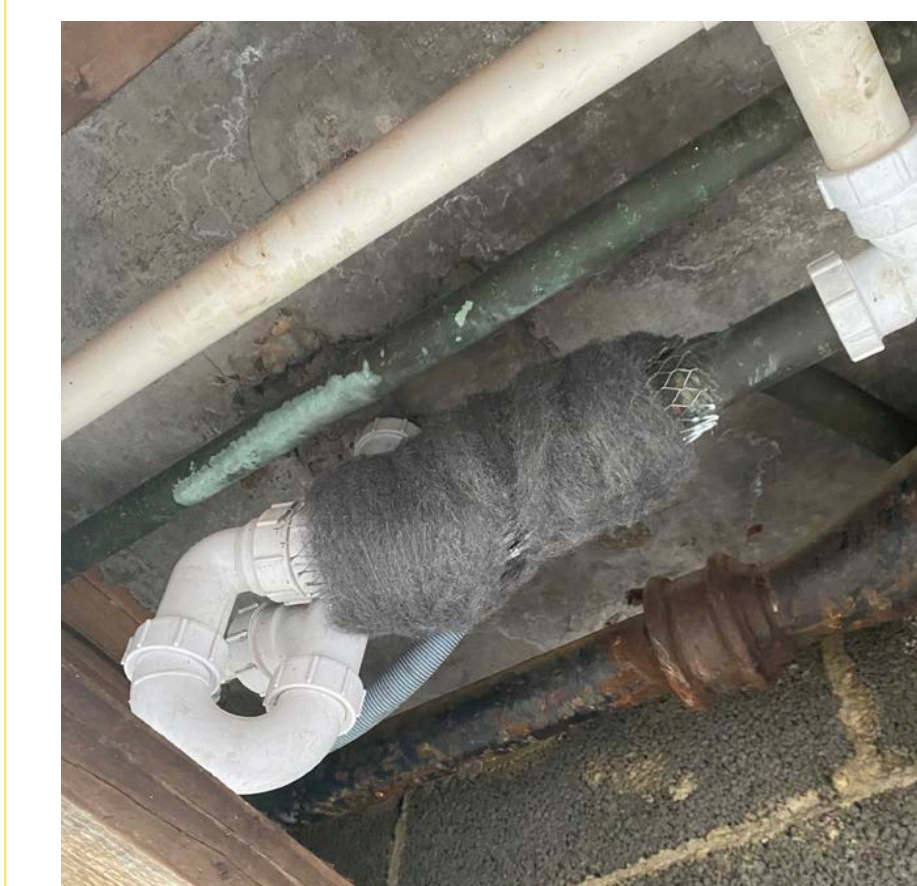
In the void flats surveyed, sections of the original pipework had been altered using modern plastic pipework and there were instances where this plastic pipework had been wrapped with flammable wire wool.

Such materials and ad hoc treatments are not suitable for maintaining fire separation, as they are liable to soften, melt, or fail under fire conditions. Given that these services penetrate floors and walls, their failure could result in the formation of openings, compromising the integrity of the fire separation and provide a potential route for the spread of smoke and fire between flats via the service penetrations.

*Plastic UPVC repair with wire wool wrapped around the pipework.*

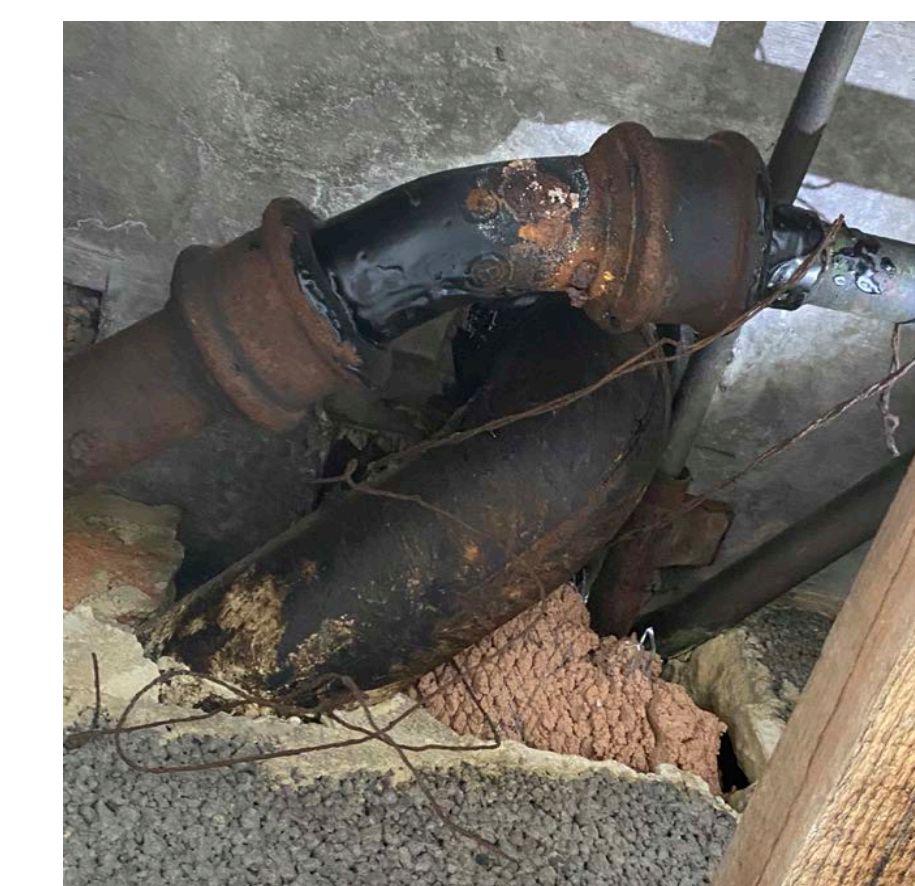
*Metal wire mesh and bonding plaster with significant gaps.*

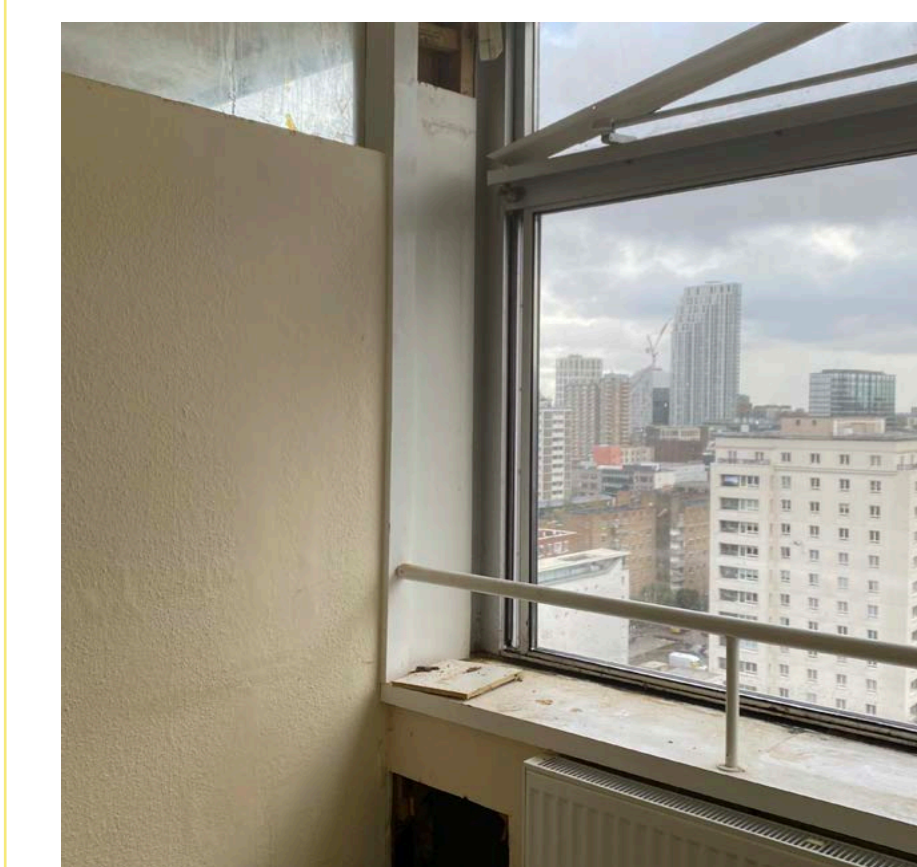
*Redundant perimeter communal heating pipework provides a potential route for smoke and fire.*

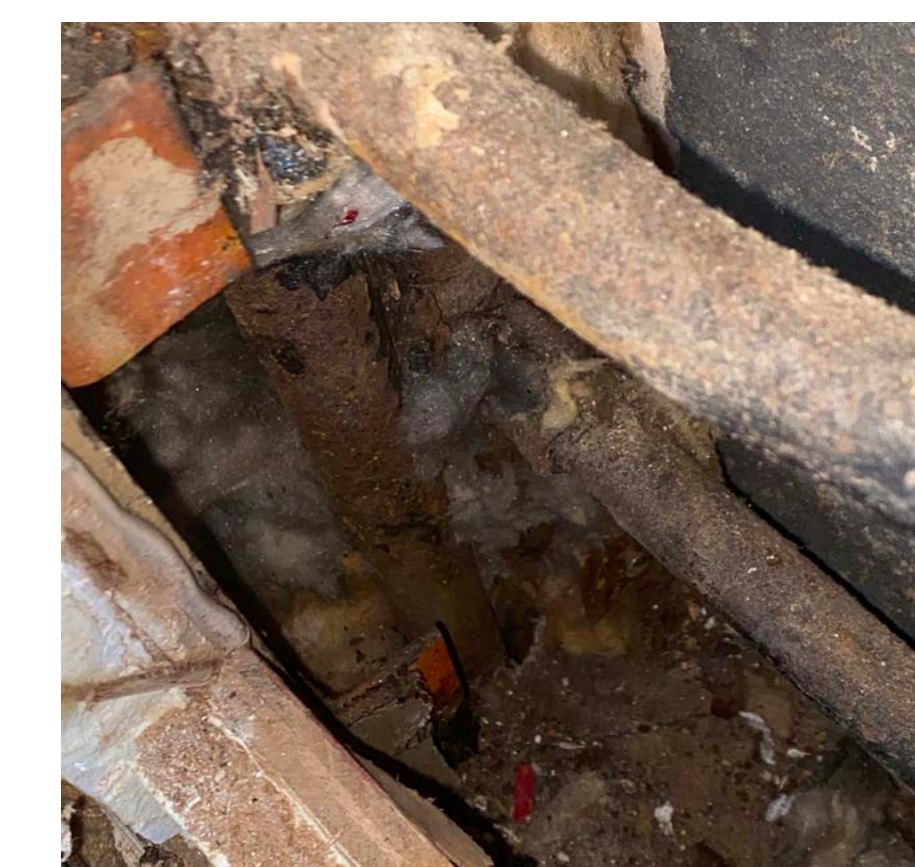
*Existing gaps around the pipe penetrations require fire stopping to maintain fire separation at floors.*

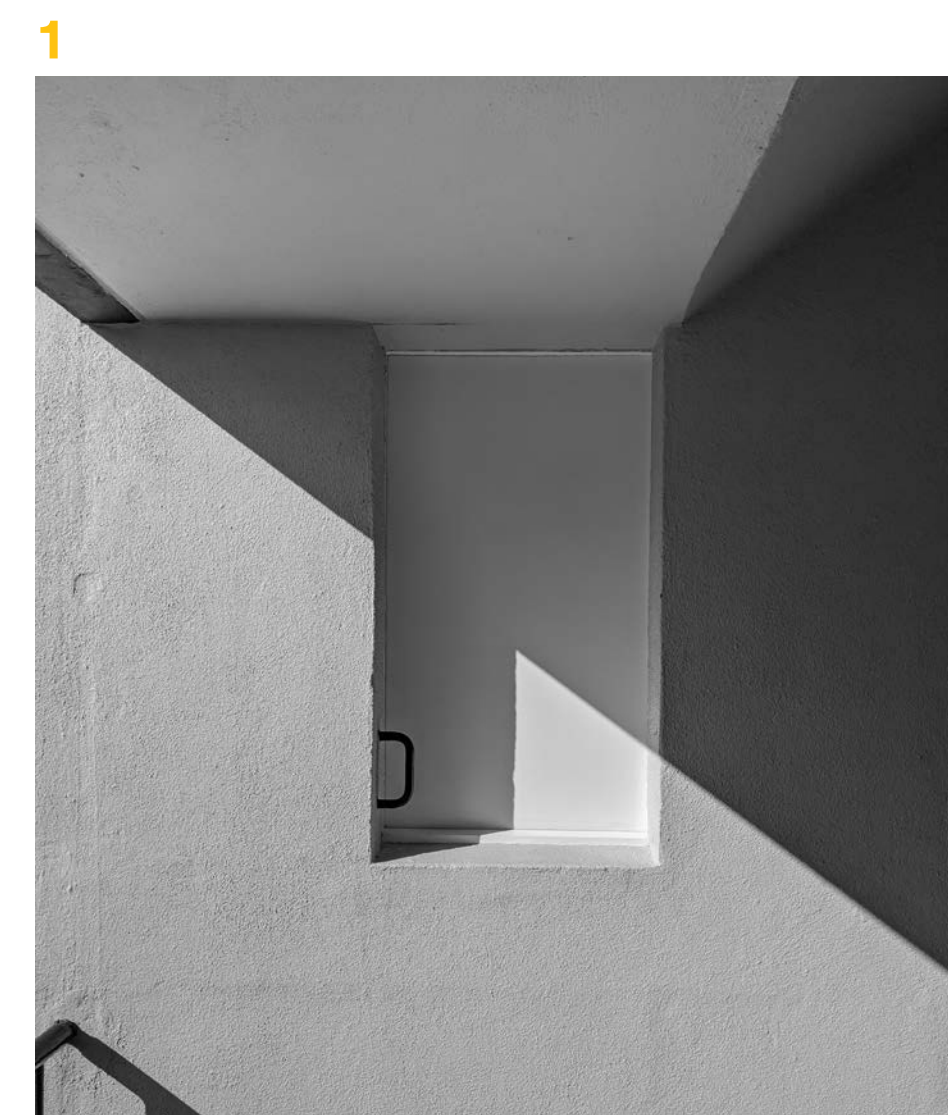
The escape hatches are 1.5m above the stair and are not very practical.

The team proposes that the exit doors and hatches are to be replaced with fire doors but sealed/boarded up from the inside to prohibit access. Replacing the doors, rather than removing them entirely and boarding up the gap left behind, prevents the heritage characteristics of Great Arthur House from being visibly altered.

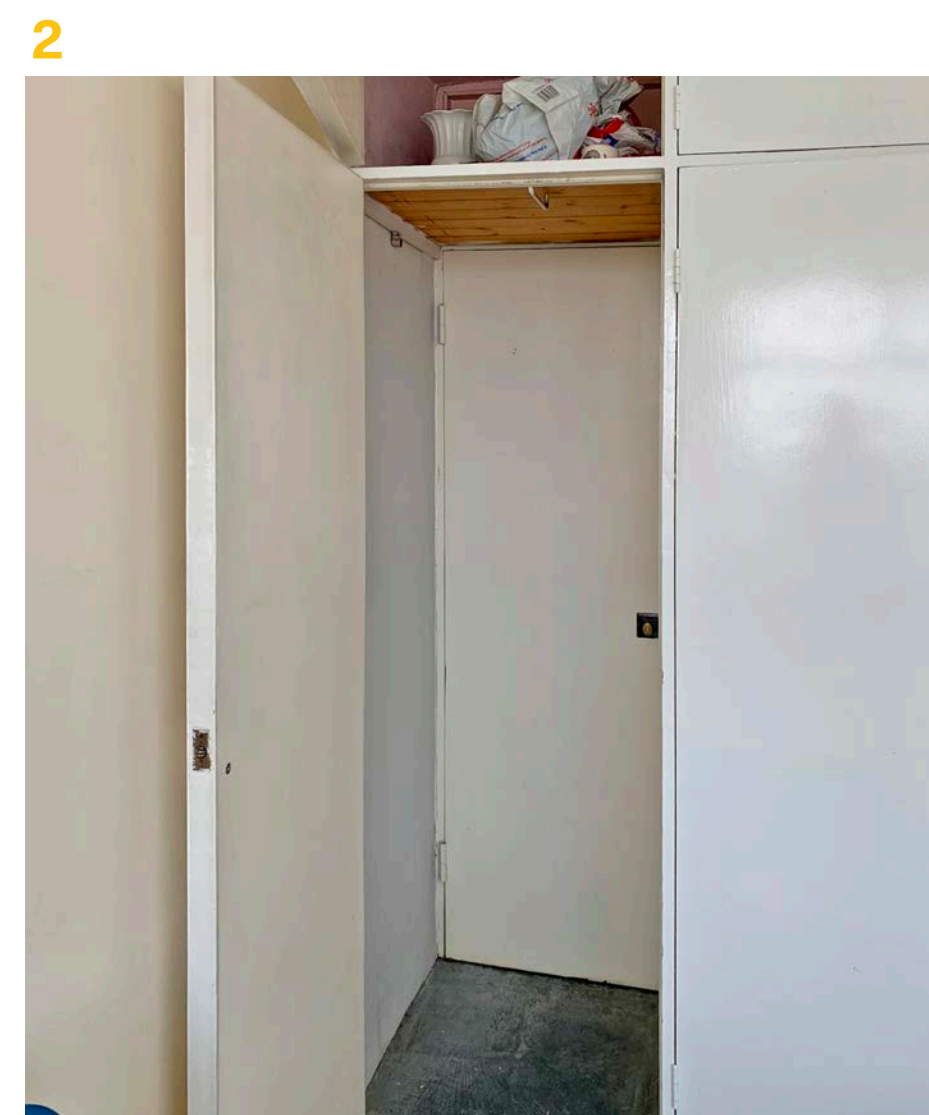
The cupboard escape routes to middle flats are often obstructed - residents may not be aware of their purpose.
