## Window Refurbishment Pilot Scheme at Crescent House, London –Acoustics Testing, Airtightness Testing, Smoke Audit and Thermography Survey

Prepared for: City of London Corporation

Date: 27<sup>th</sup> March 2023

Report Number: P125003 - 1001 Issue 1

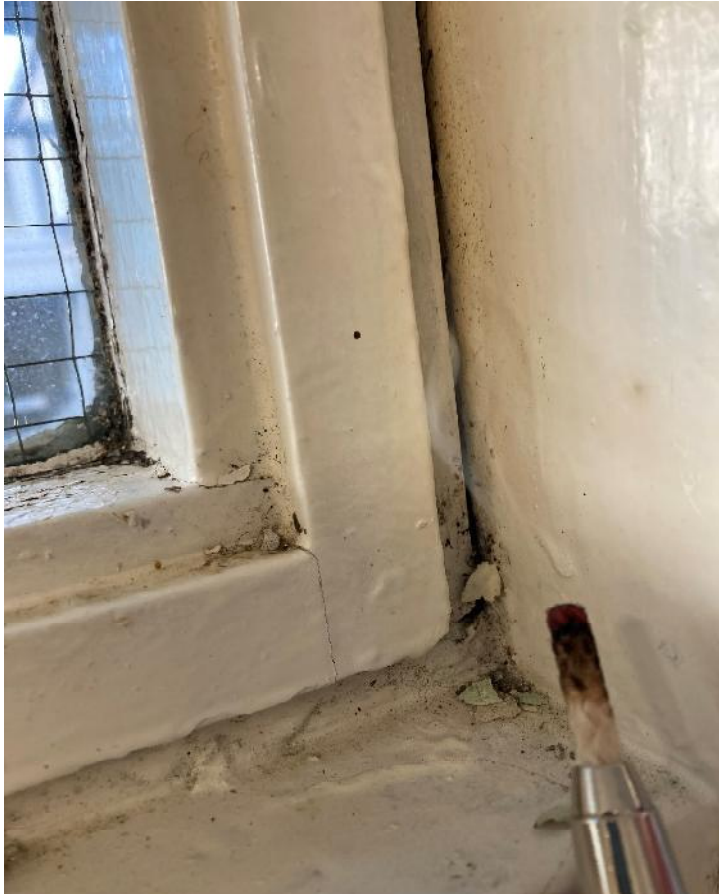
**Photograph 3:** Air Leakage - kitchen window (SAL1)

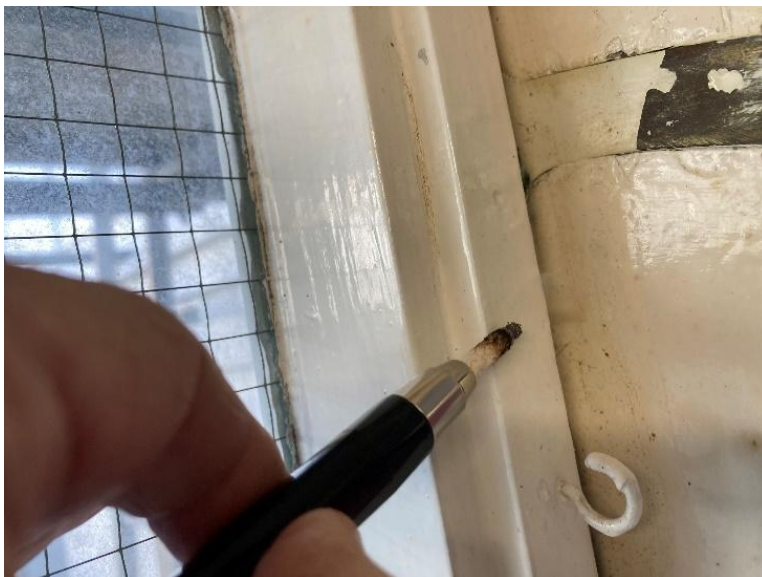
**Photograph 4:** Air Leakage - kitchen window (SAL2)

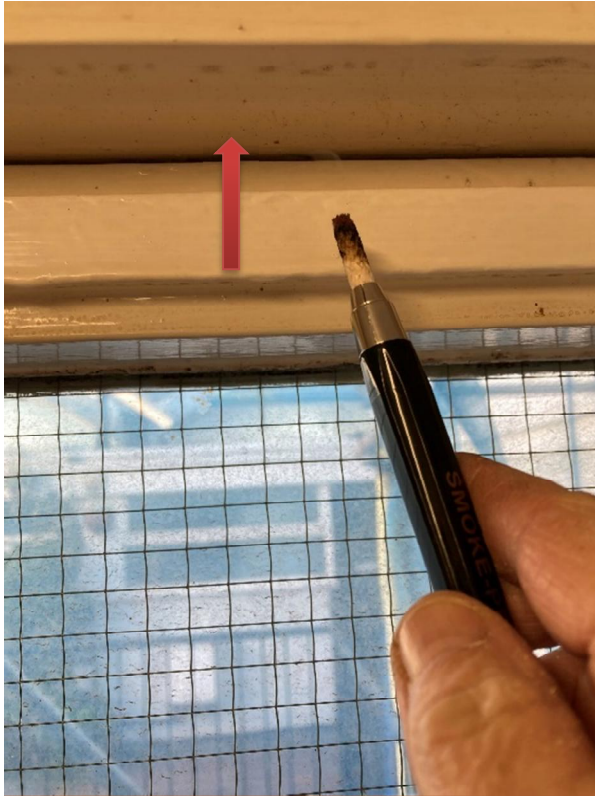
**Photograph 5:** Air Leakage - kitchen window (SAL3)

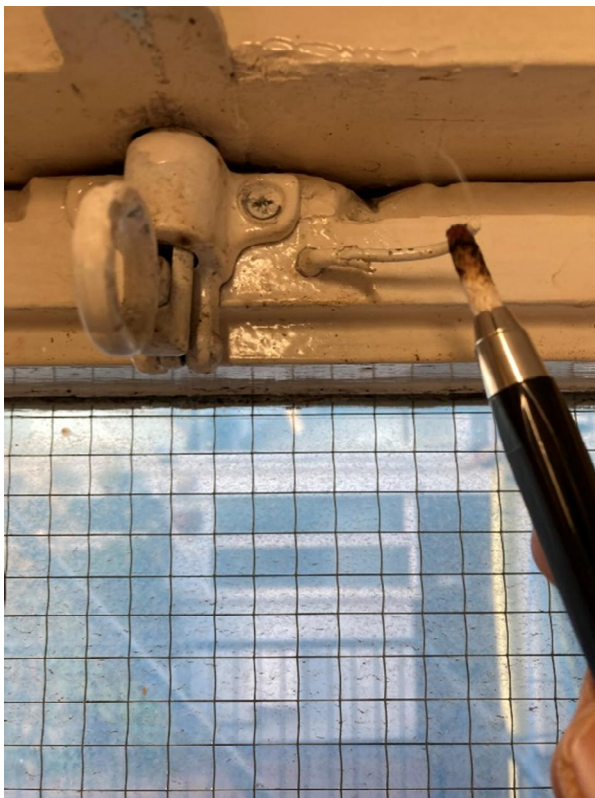
**Photograph 6:** Air Leakage - kitchen window (SAL4)

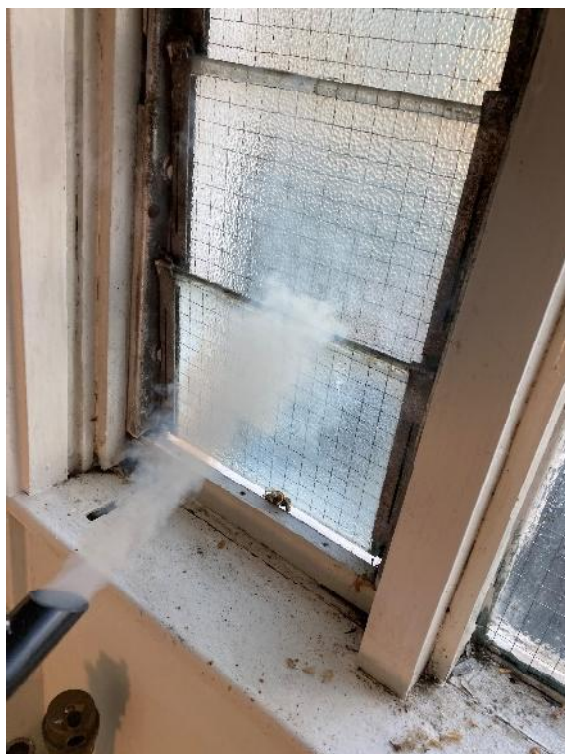
**Photograph 7:** Air Leakage – bathroom louvre (SAL5)

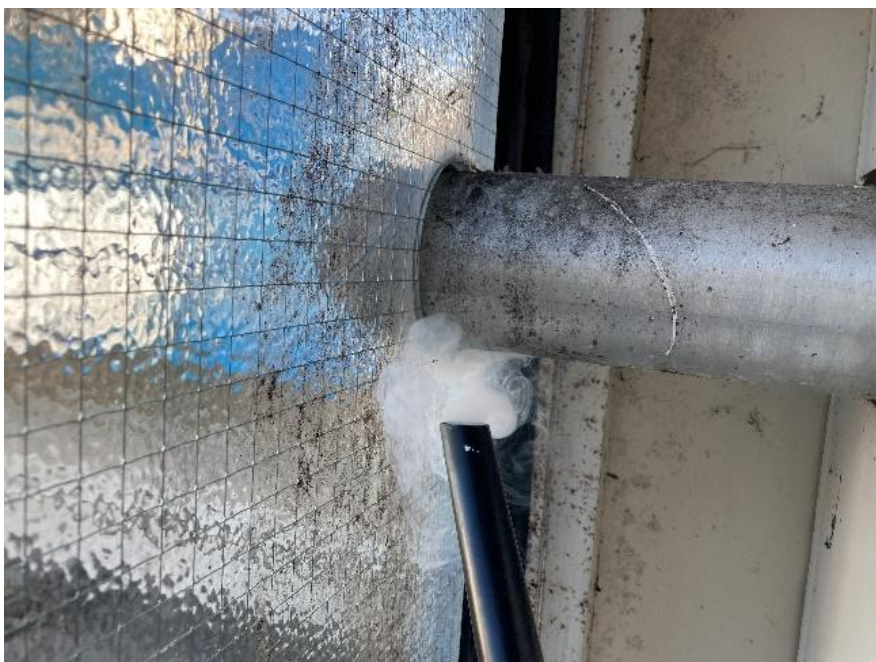
**Photograph 8:** Air Leakage – bathroom flue (SAL6)

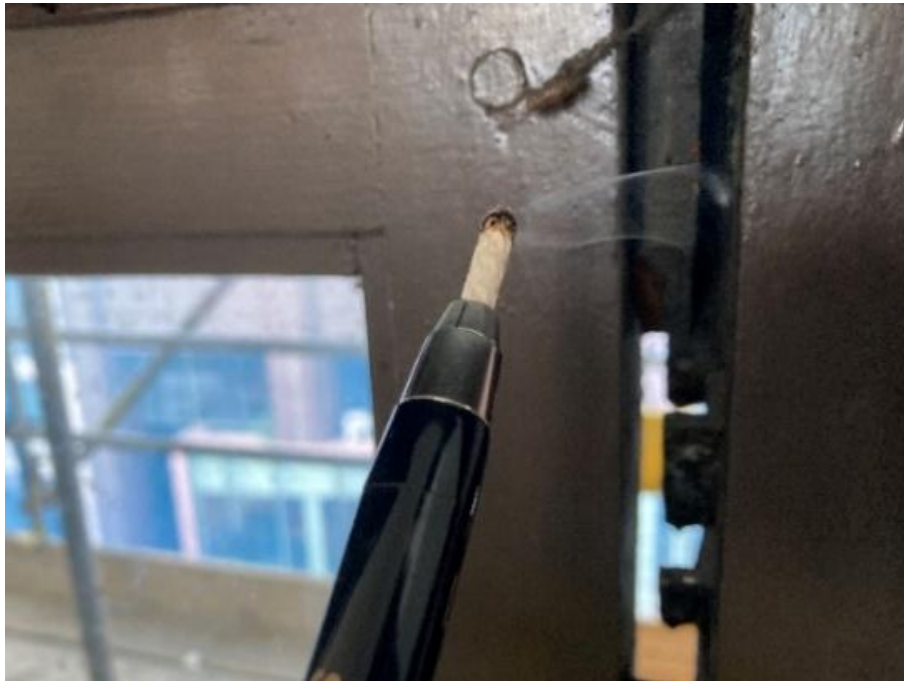
**Photograph 9:** Air Leakage – main window frame (SAL7)

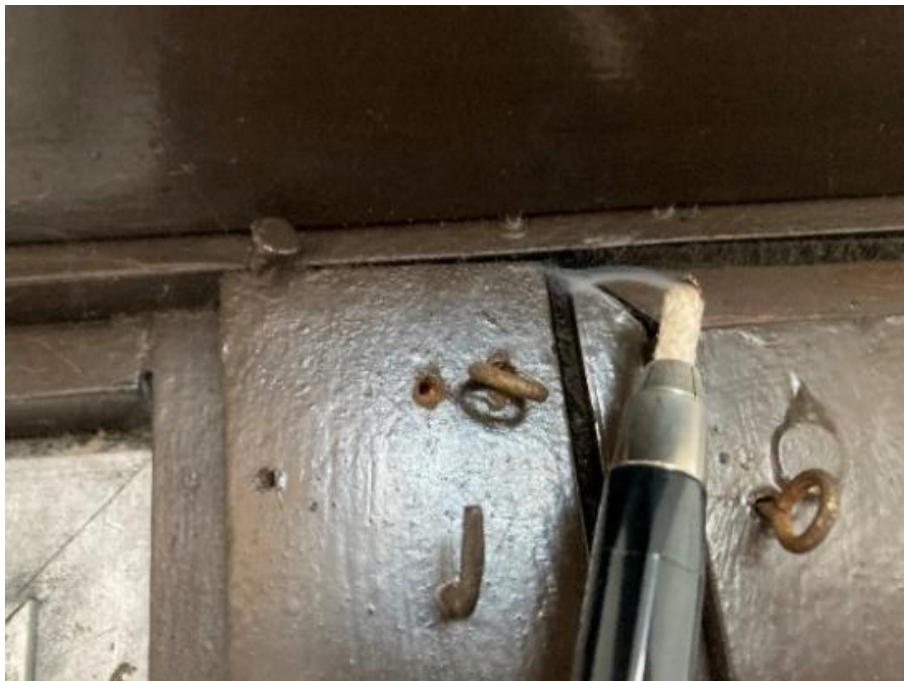
**Photograph 10:** Air Leakage – window frame (SAL8)

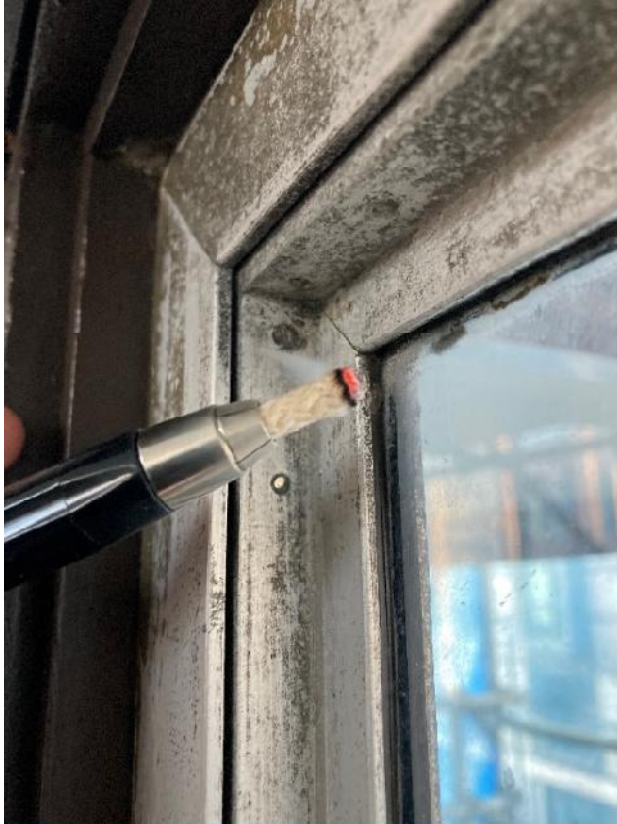
**Photograph 11:** Air Leakage - window frame (SAL9)

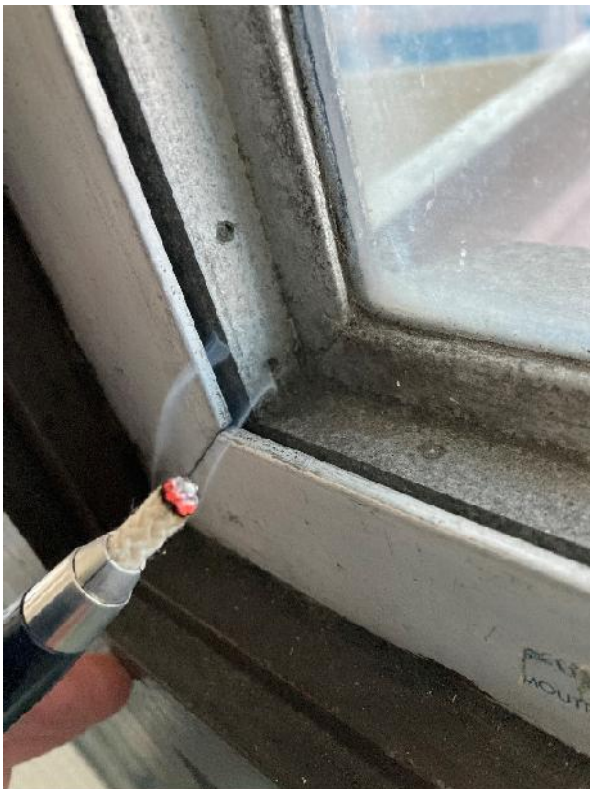
**Photograph 12:** Air Leakage - window frame (SAL10)

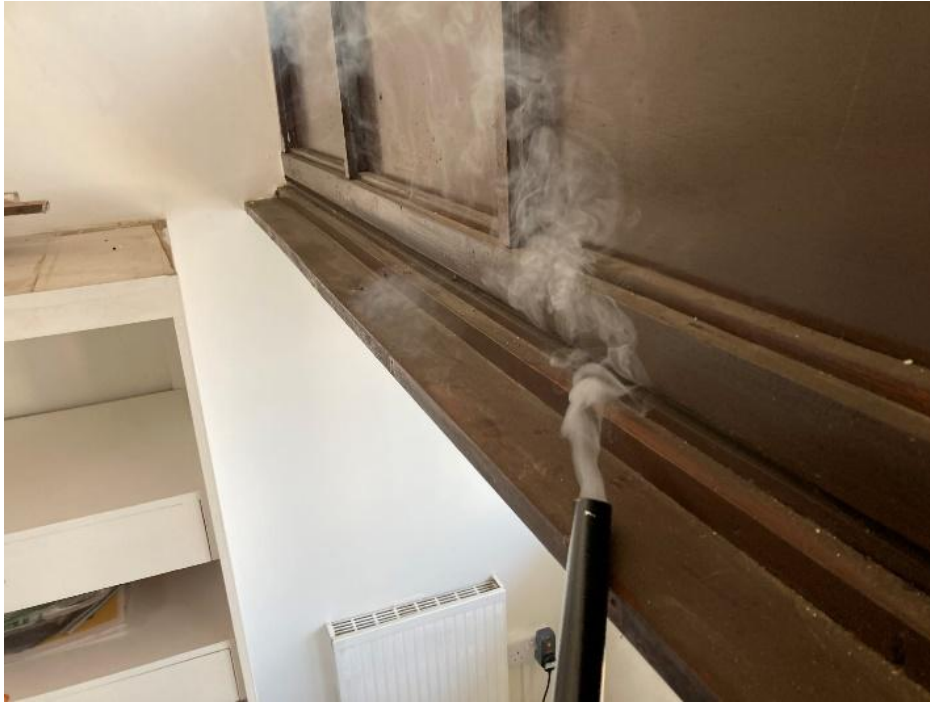
**Photograph 13:** Air Leakage - window frame (SAL11)

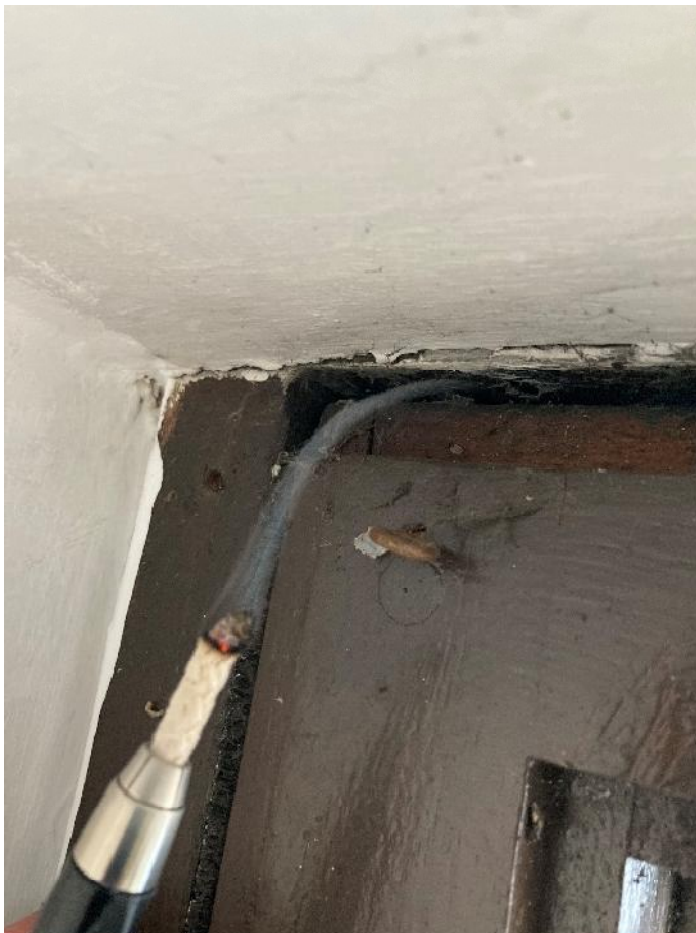
**Photograph 14:** Air Leakage - window frame (SAL12)

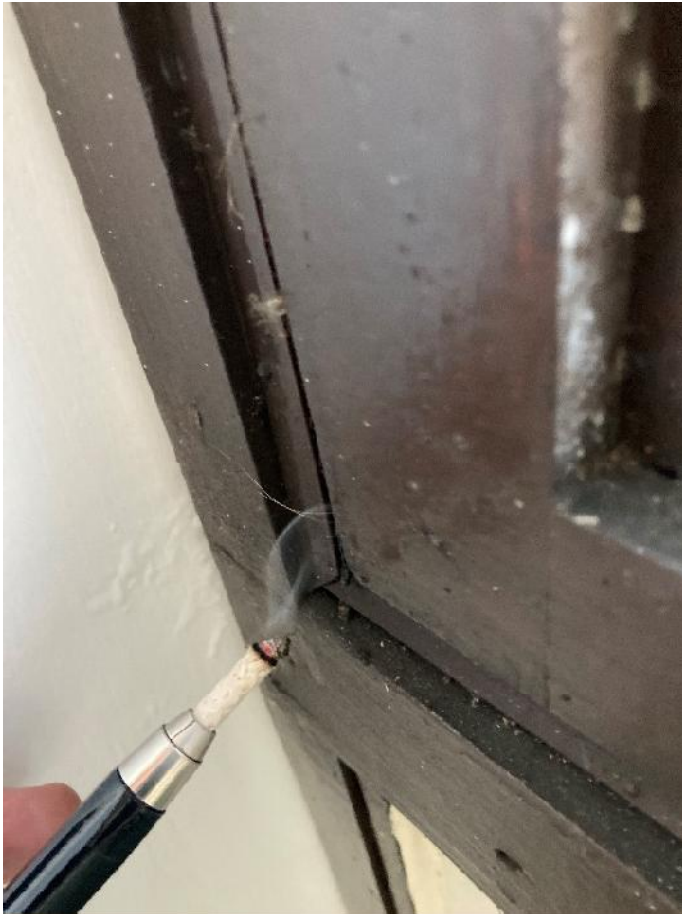
**Photograph 15:** Air Leakage - window frame (SAL13)

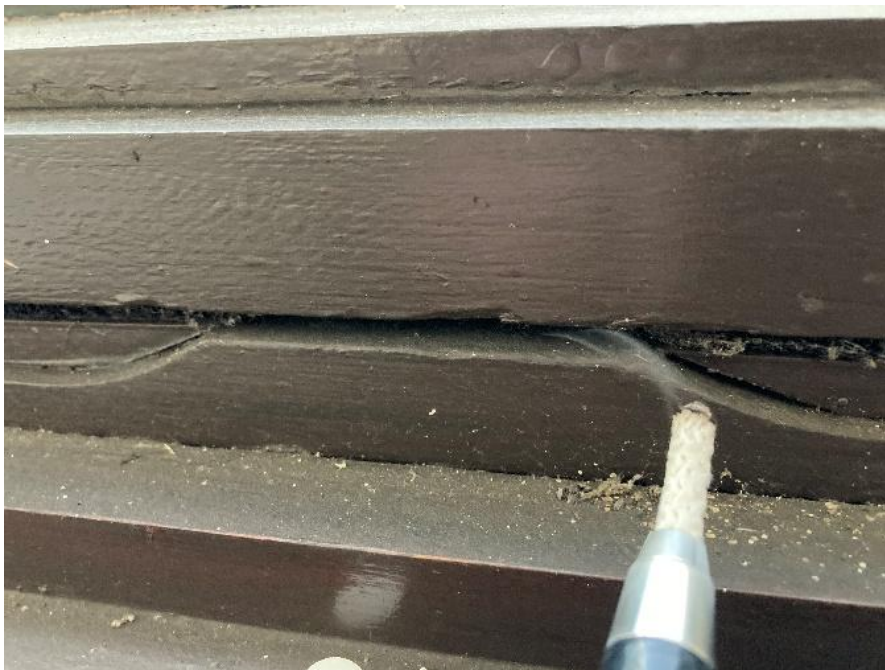
**Photograph 16:** Air Leakage - window frame (SAL14)

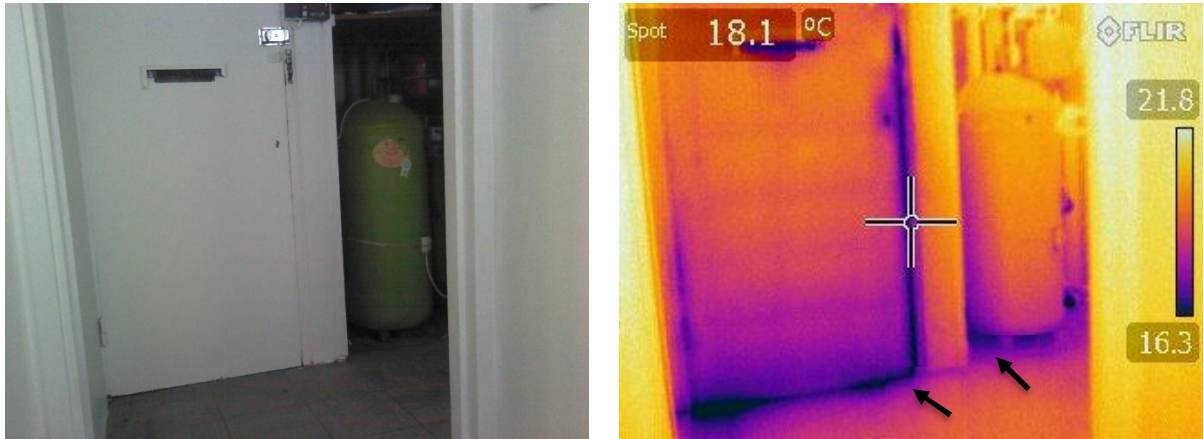
**Figure 8:** Thermal Image entrance heat loss highlighted Location THL1 (see Figure 6)

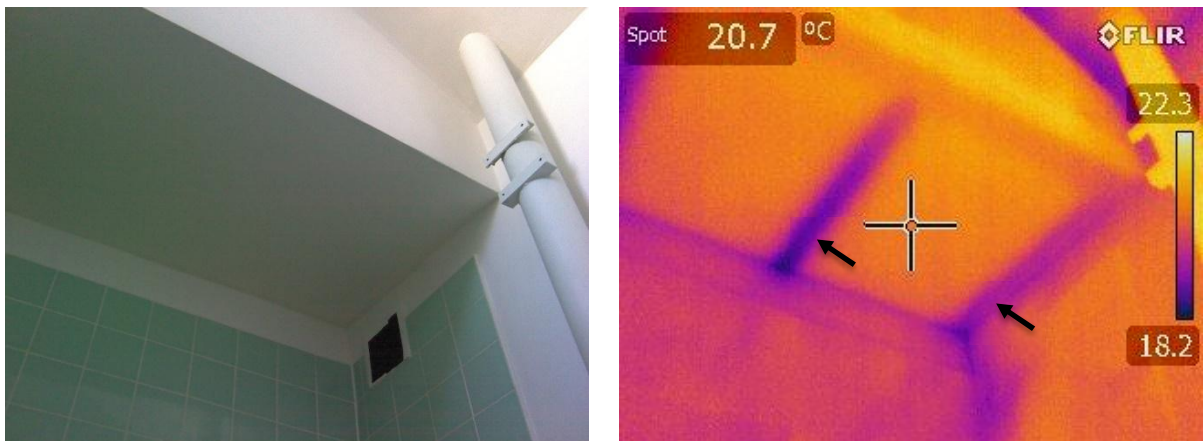
**Figure 9:** Thermal Image bathroom, heat loss highlighted THL2.

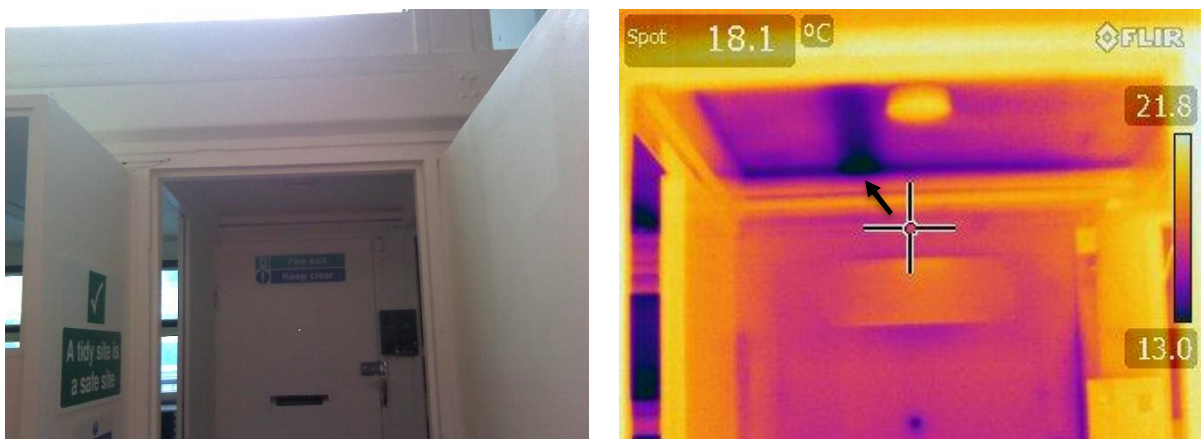
**Figure 10:** Thermal Image Hall, heat loss highlighted THL3.

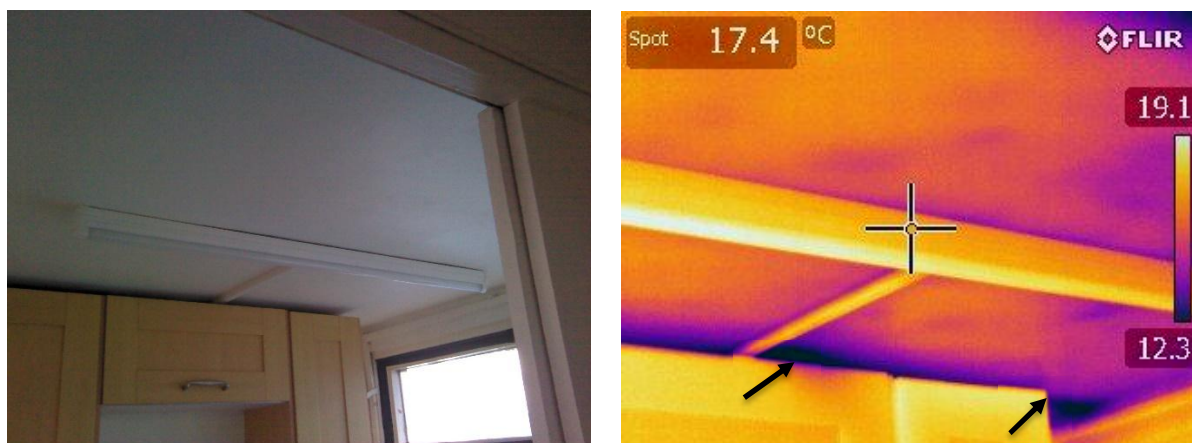
**Figure 11:** Thermal Image kitchen - heat loss highlighted Location THL4

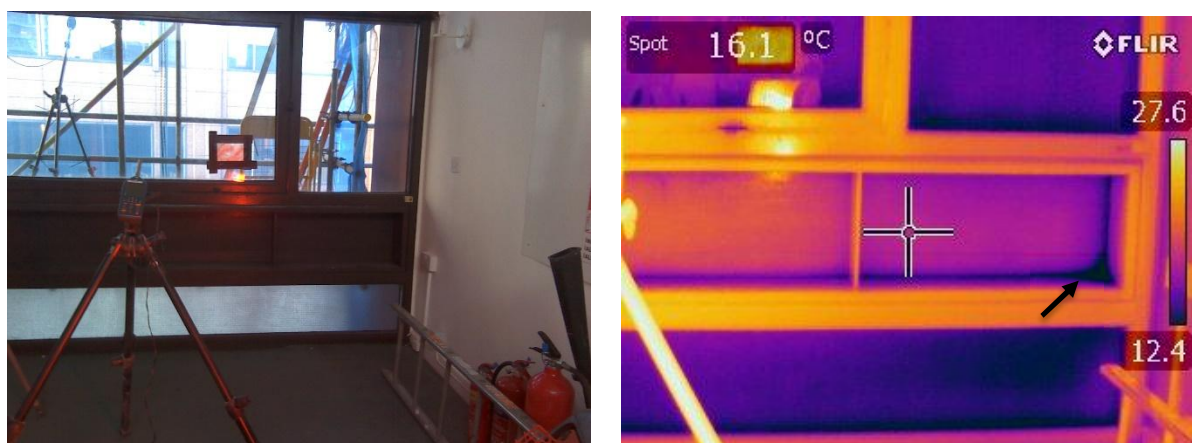
**Figure 12:** Thermal Image shelving - heat loss highlighted Location THL5 (see Figure 7)

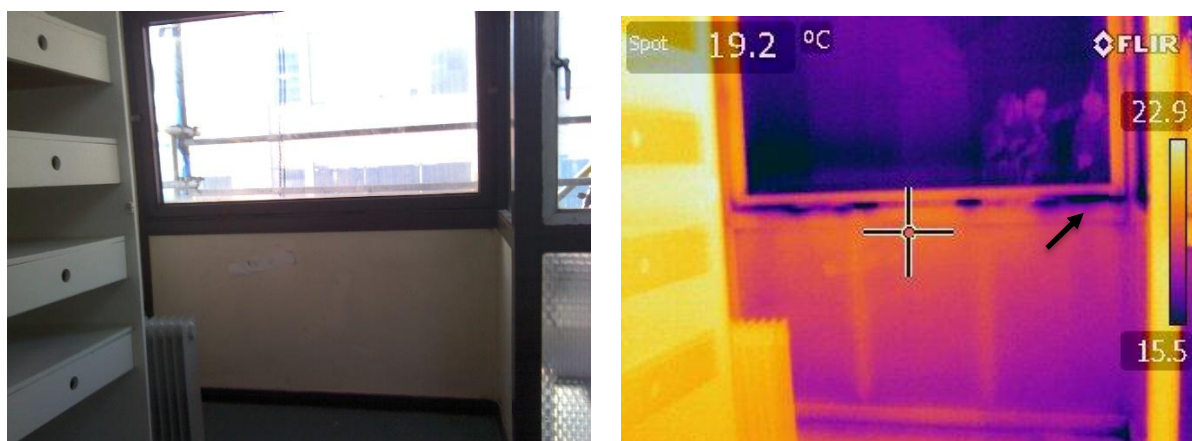
**Figure 13:** Thermal Image front window - heat loss highlighted Location THL6

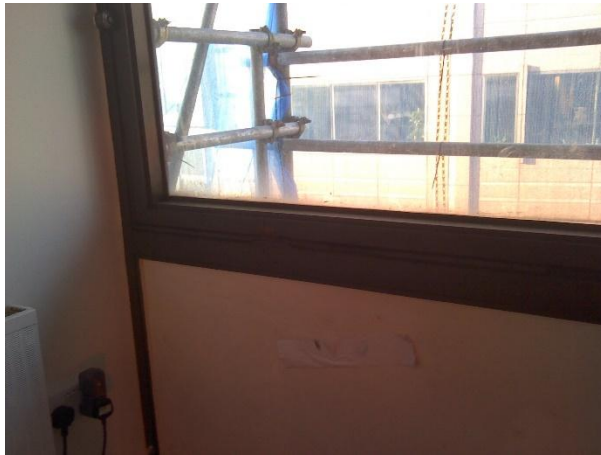
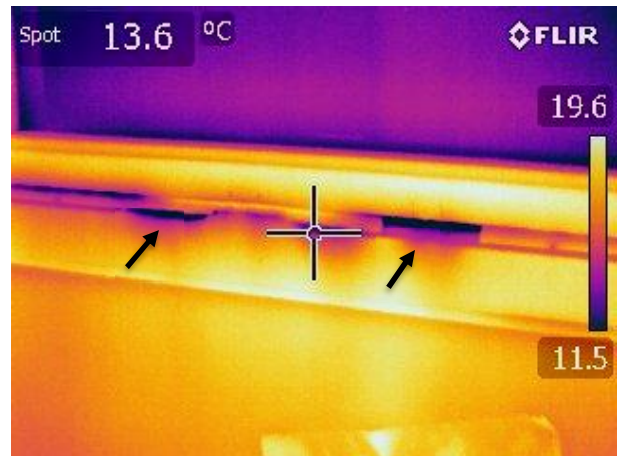
**Figure 14:** Thermal Image - close up of front window - heat loss highlighted Location THL6

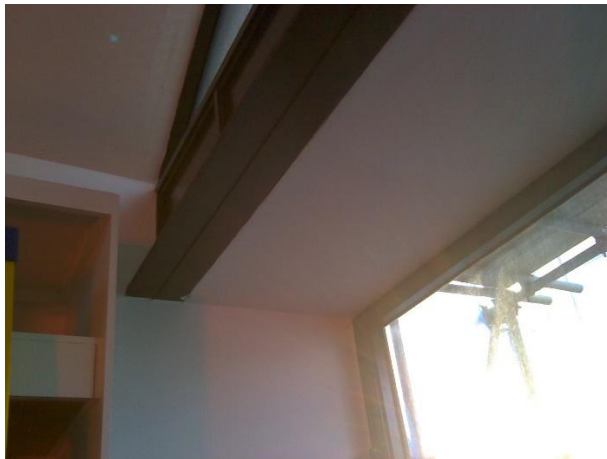
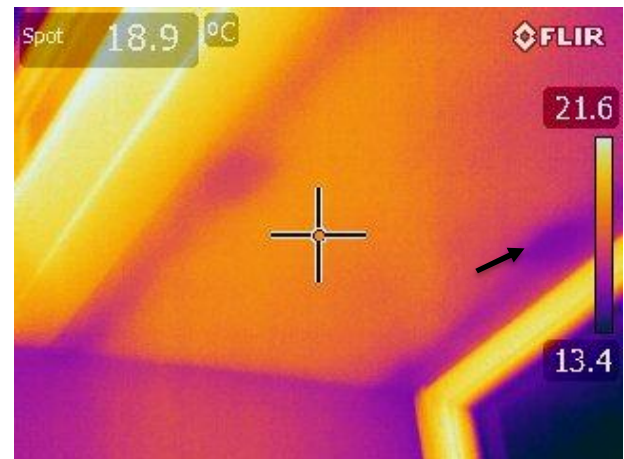
**Figure 15:** Thermal Image - front window reveal - heat loss highlighted Location THL7

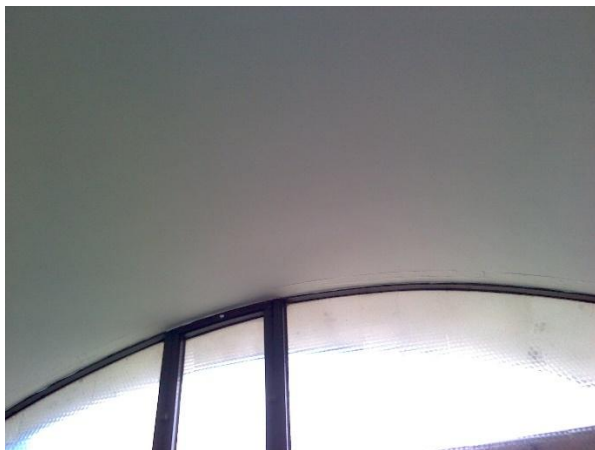
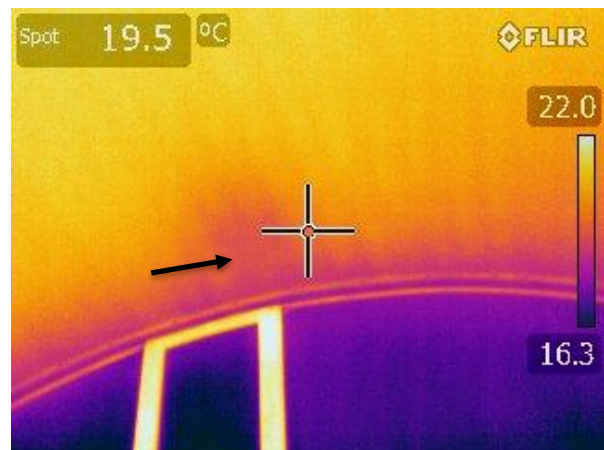
**Figure 16:** Thermal Image - front window roofline - heat loss highlighted Location THL8
