# SCOPE OF WORKS

Great Arthur House previously had separated project briefs: repairs to kitchen and bathroom windows, fire compartmentation upgrades, and sprinkler installation. The revised brief consolidates these elements and has been relaunched as one complete package of works.

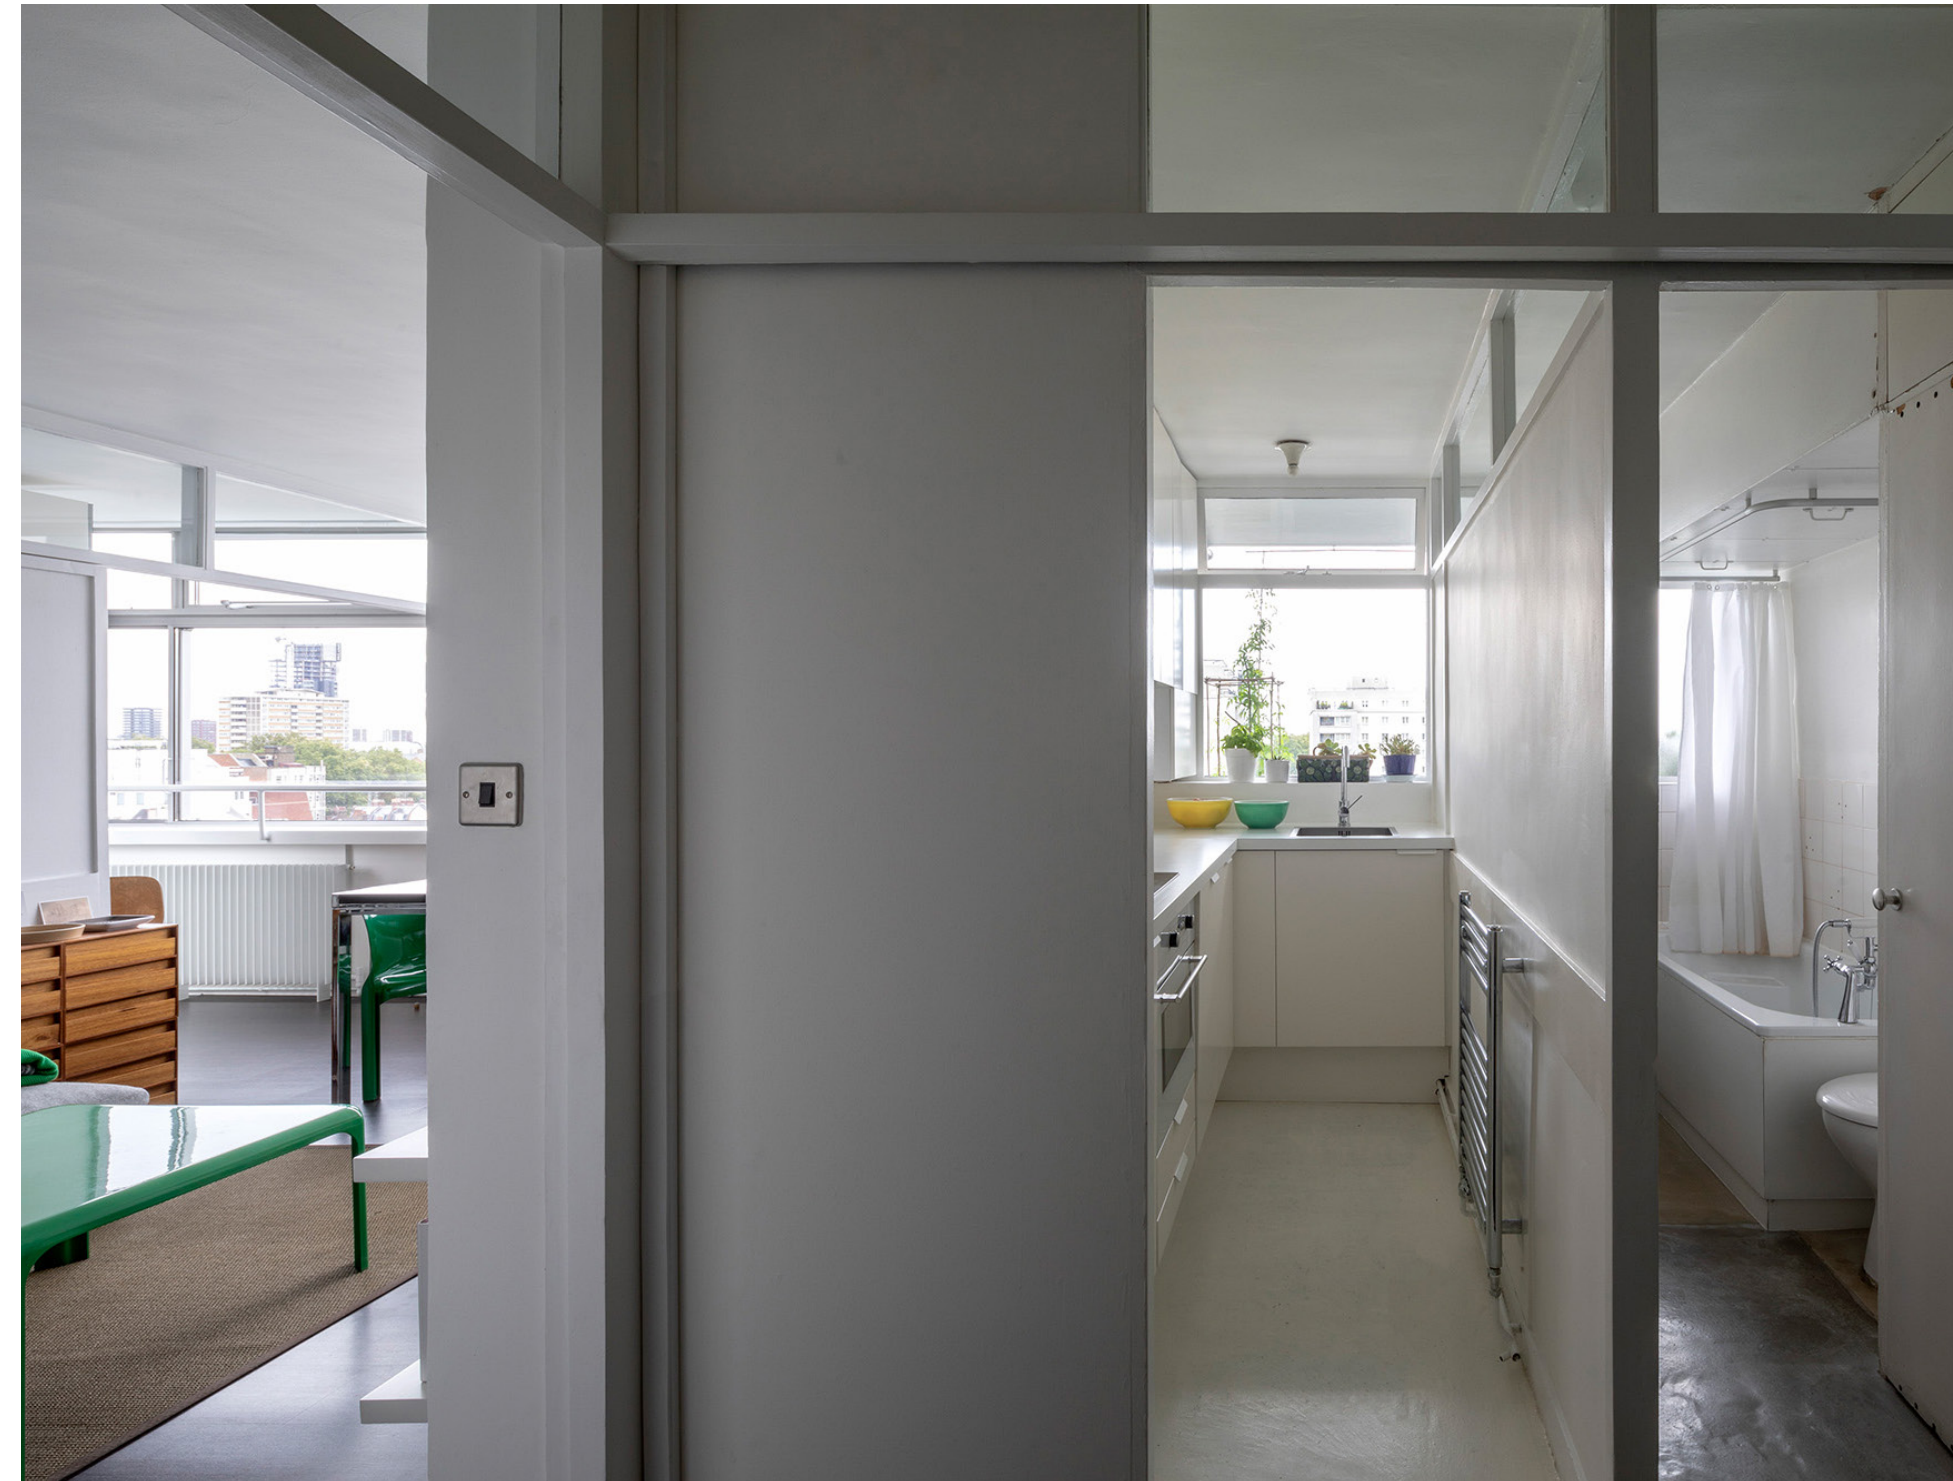
Full height timber glazed partitions separating the living room and bedroom, including the original sliding partition, and the fixed glazed partition between the kitchen and bathroom.

The relationship between the head of the partition and the ceiling is a heritage consideration.

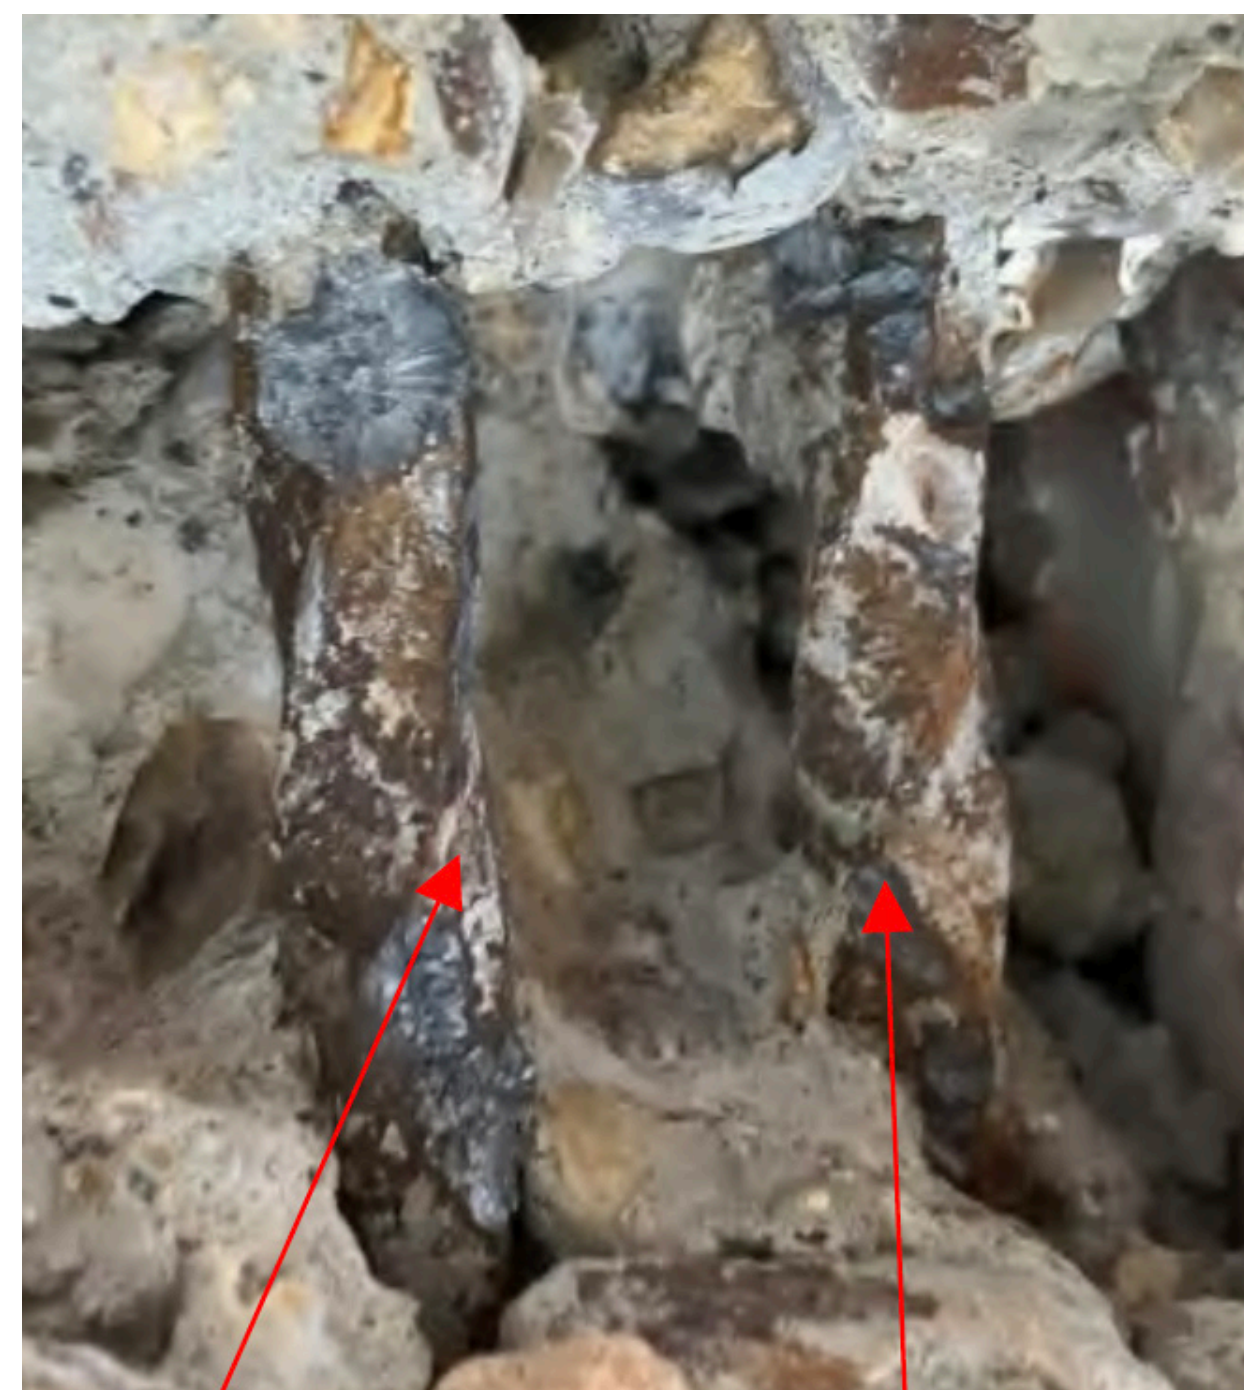
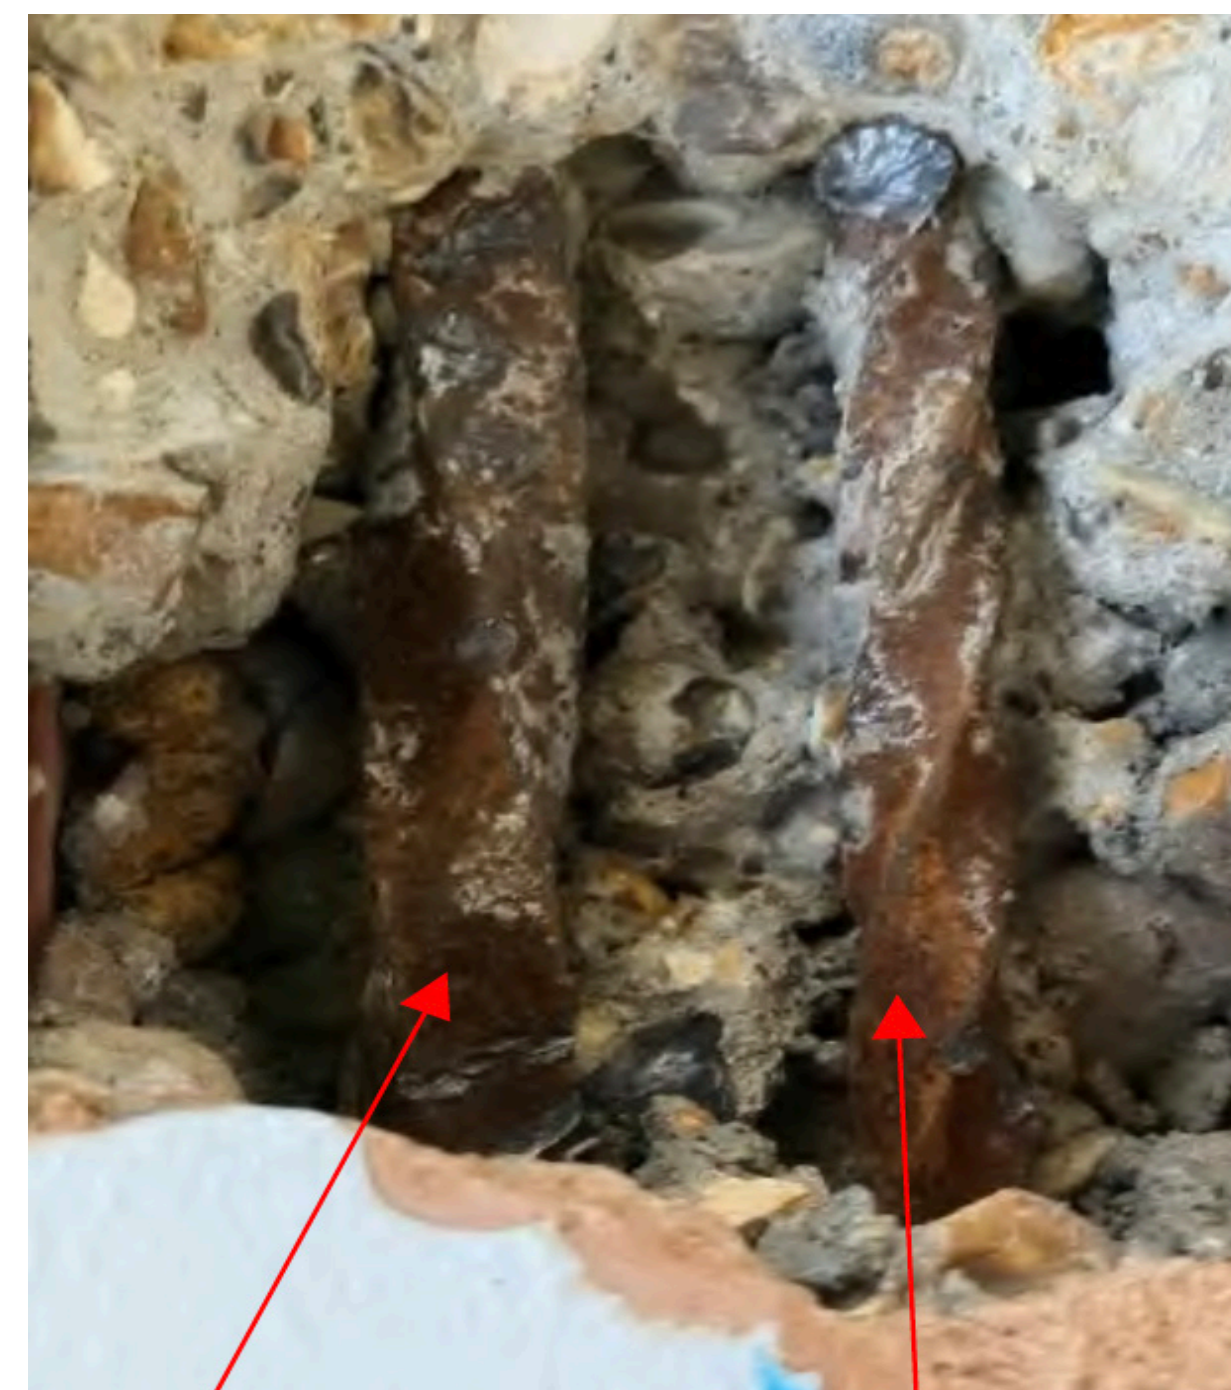
An intrusive survey found the concrete cover to the steel reinforcement varied from approximately 7 mm to 23 mm, with some areas below the 20 mm typically required for fire protection and durability. The survey also identified carbonation in some poorly compacted concrete, meaning the concrete around the steel was no longer providing adequate protection against corrosion where moisture and oxygen are present.

The team have explored potential remedial solutions to enhance the fire protection to the underside of the slabs, with the aim of achieving 120 minutes fire resistance.

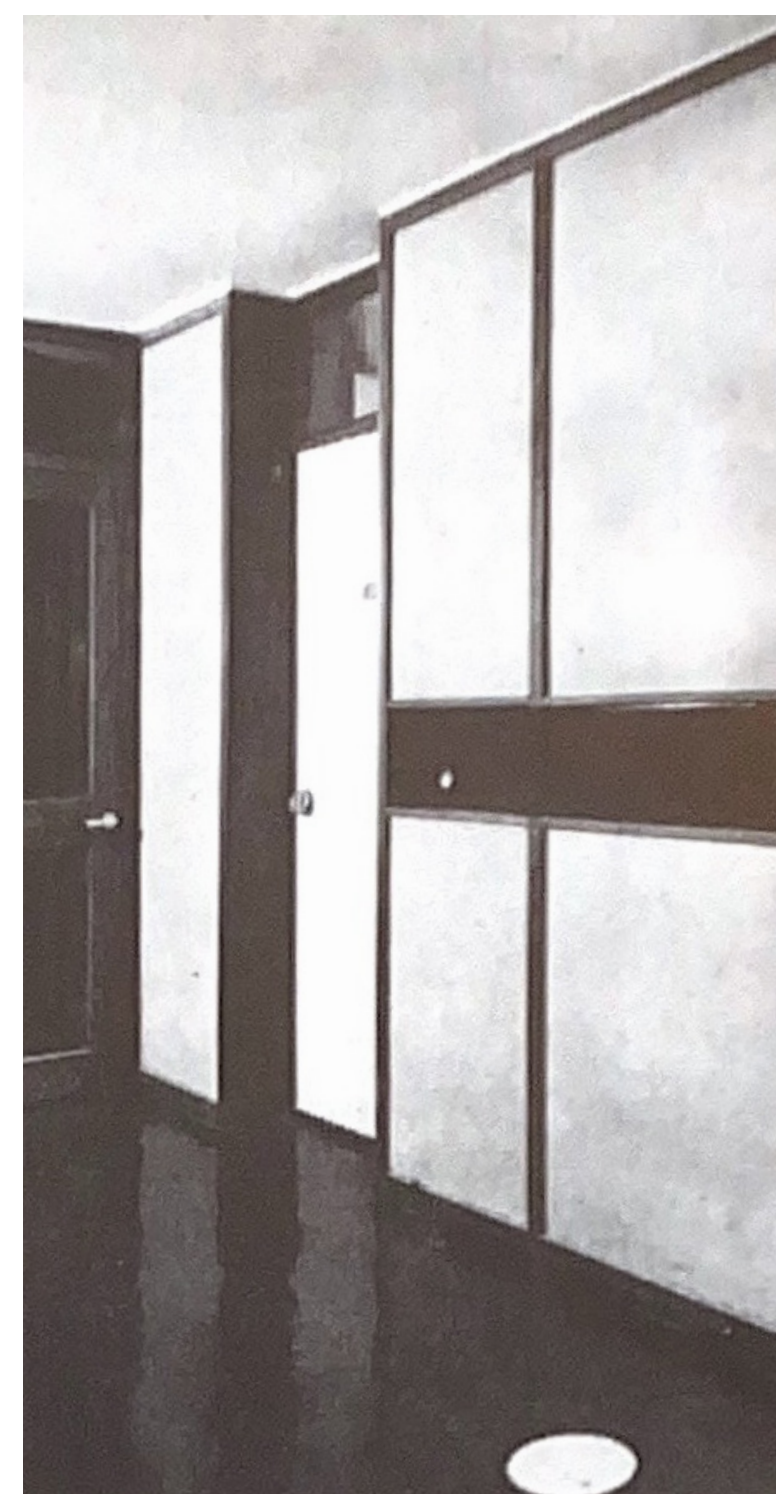
Original condition.

They also contain original features namely the parcel hatches and letterboxes. These openings create potential routes for fire and smoke spread. As a result, the entrance screens provide only limited fire protection between the flats and the communal escape routes.

Flat front entrance doors are also integrated into the timber frame of the screens, making them part of the fire separation line between flats and common areas. As the doors do not provide the required fire protection, they will also need to be replaced with suitable fire doors.

Of the options considered so far, a version using a 'Shaftwall' system, can achieve a fire separation line. The new fire doors will be integrated into the design.

Installing the lining to the rear of the screen creates a simple, continuous fire-protecting line while allowing the front of the entrance screens to retain their historic appearance. However, the letterboxes and parcel hatches would no longer be accessible from inside the flat. Furthermore, the two storage cupboards inside the flat could no longer be used and another would be slightly reduced in size.

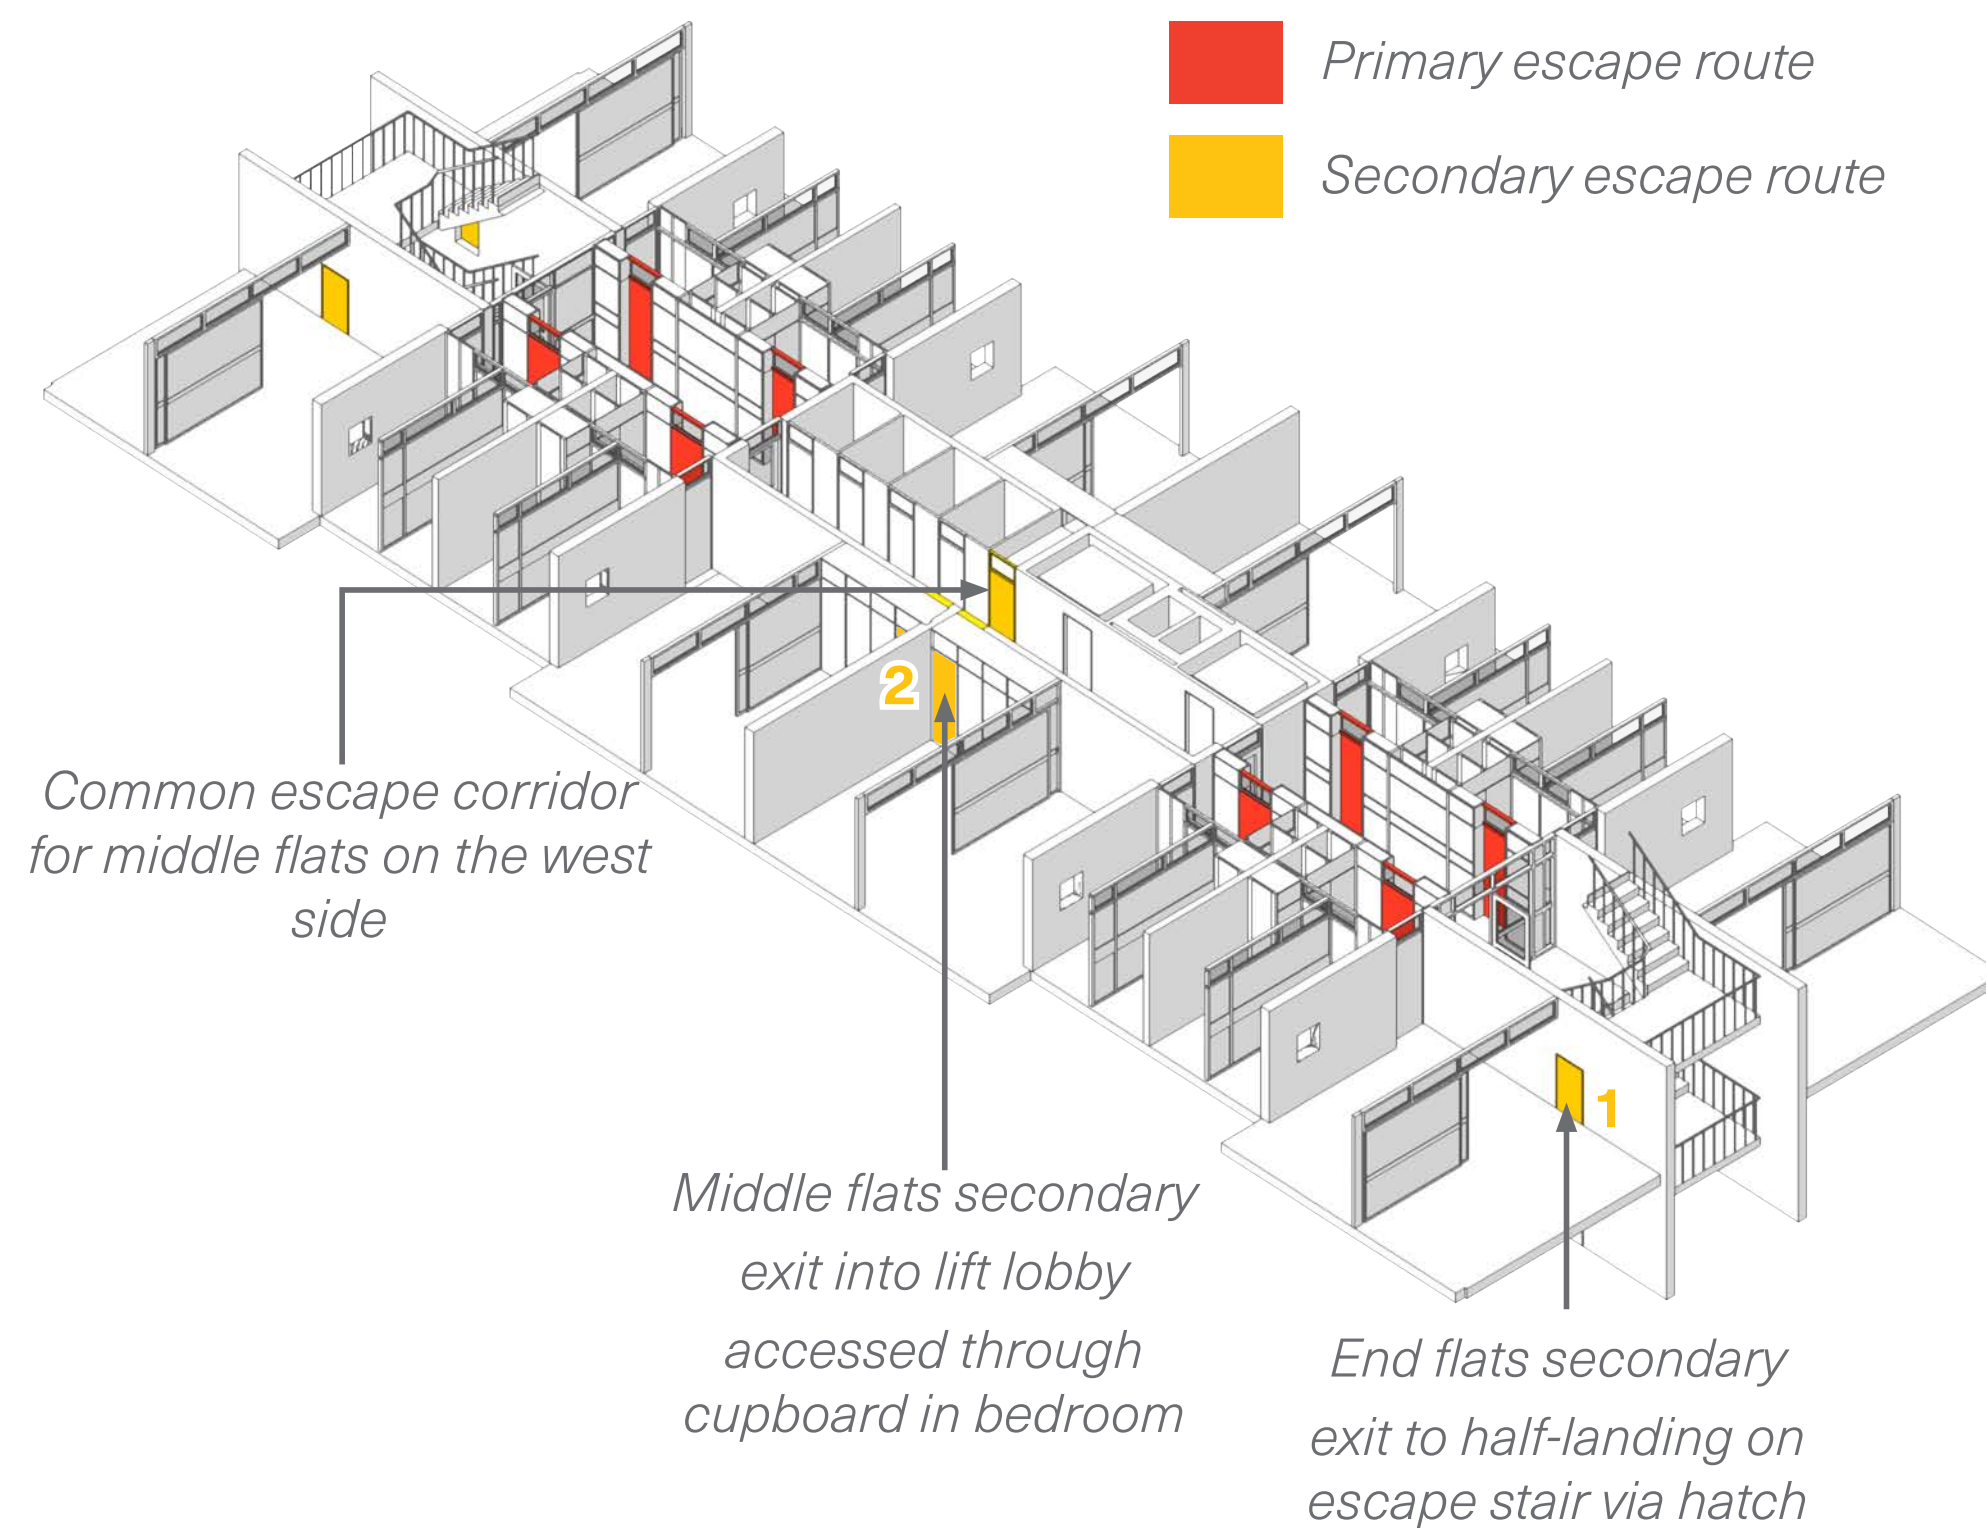
The guidance in place at the time of construction did not fully address smoke spread through the lift shafts. Alternative escape routes from flats open directly into lift lobbies without smoke ventilation, allowing smoke from a fire to spread into the lobby and travel to other floors via the lift shaft.

The escape hatches are 1.5m above the stair and are not very practical.

The team proposed to remove the use of these alternative escape exit points and provide smoke ventilation to protect the stair and lift lobbies.

The team proposes that the exit doors and hatches are to be replaced with fire doors but sealed/boarded up from the inside to prohibit access. Replacing the doors, rather than removing them entirely and boarding up the gap left behind, prevents the heritage characteristics of Great Arthur House from being visibly altered.
